Analysis of the causes of failure in 5Cr-1Mo pipes mounted in a preheating furnace

ABSTRACT. The oxidation resistance of iron-based alloys depends on the formation of thin protective films consisting of reaction products between the alloys and the ambient atmosphere. The high corrosion resistance of Fe-Cr-Mo alloys has been attributed to the rapid formation of a uniform, highly protective passive film. The pipes hardness and resistance to various forms of corrosion are determined by the composition of the oxide layer that plays an important role in determining the lifetime of the pipes themselves. The thermal stability of the oxide layer is influenced by its composition and thickness as well as by the bond to the underlying metal.

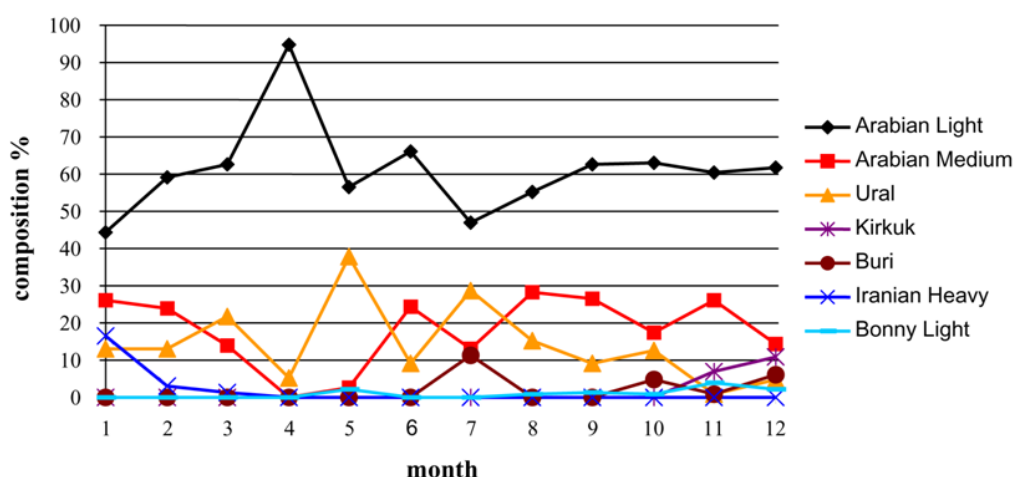
During year 3 the charge of the crude oil was modified. The Fig. 1 shows the trend of the charge v.s. the time (month) and highlights the following differences in crude composition:

- Arabian Light: a maximum equal to 95% in the feed takes place in April month. This value remains steady AT 60% in the following month.
- Arabian Medium: its percentage in the feed falls to 0% in April, along with the increase in Arabian Light's percentage. The flow rate of Arabian Medium increases in May and reaches about 21% in the following months.
- Ural: low percentages (about 13%) have been present since January. Maximum value of 37% takes place in May, and then stabilizes at 11%.
- Since May small amounts (about 2%) of Buri, Kirkuk, Iranian Heavy and Bonny Light were added.

Figure 1: Crude composition (weight %) during the penultimate operating year.

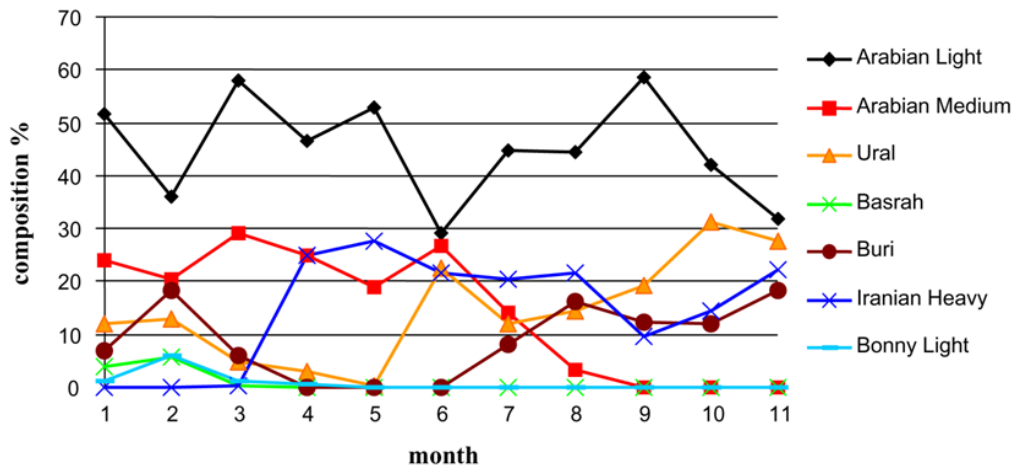
During the last operating year another variation in the charge of the crude oil was observed. Fig. 2 shows the trend of the charge v.s. time and highlights the following differences on crude composition:

Figure 2: Crude composition (weight %) during the last operating year.

In November the feed's composition was: 31.77% Arabian Light, 27.67% Ural, 18.36% Buri and 22.20% Iranian Heavy. As a consequence of this crude oil charge, a variation in the working conditions of the pipes is observed:

- ✓ sulphur percentage entering the furnace $S\% = 3.3$;
- ✓ TAN of the feed charge entering the furnace 0.39.

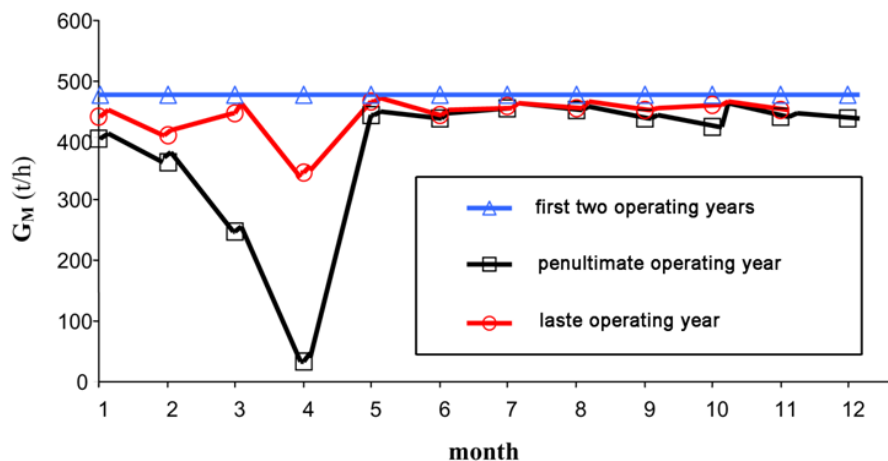
Annual graphic of the crude blending mass rate G_M (t/h) in function of time (month) is shown in Fig. 3. In the penultimate operating year a relevant but slow decrease in the flow rate is shown from January to April. A fast increase occurred from April to May.

During the last operating year, again, a flow rate decrease is noticed in April, but this is negligible compared to the one which occurred in the penultimate operating year.

The data processed in the atmospheric distillation unit shows that the thickness of the pipe walls during the last two operating years decreased from 7.14 mm to 4.30 mm.

Figure 3: Comparison of crude blending mass rate v.s. the time.

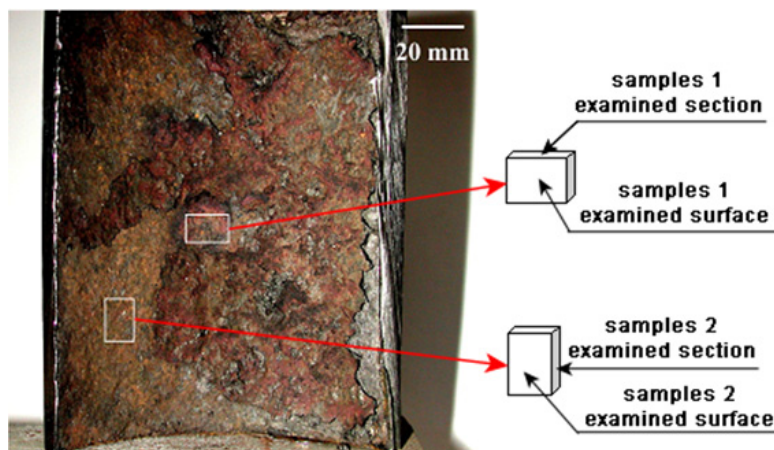
For this purpose two samples were taken from the investigated corroded pipe as shown in Fig. 7.

Figure 7: Areas of sampling; sample1: pit zone; sample2: scale zone.

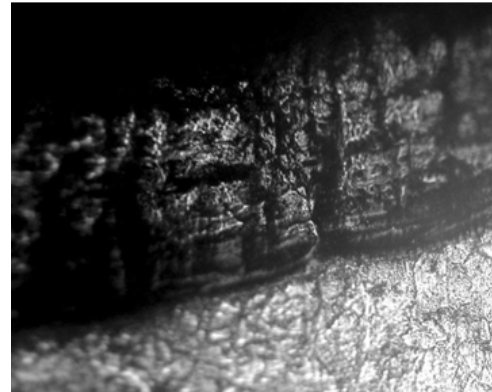
Figure 9: Micrographic analysis. Under site of scale surface. Discontinuous scale due to pronounced penetration. – 200 X.

The side section of sample 2 (Fig. 7) was examined to investigate the region under the scale (Fig. 9). This region shows a deep intergranular penetration. In fact the surface scale appears very discontinuous.

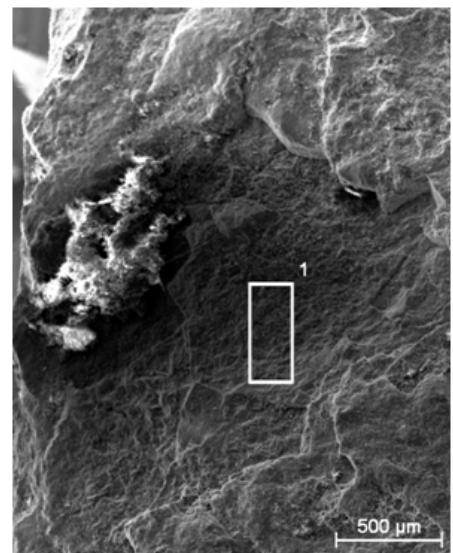
The surface of the pit valley was examined (Fig. 7 – sample 1 surface). Fig. 10 and its magnification, Fig. 11, show the surface of the pit valley, badly damaged and the porous and sponge-like scale, no longer protective. EDS analysis was carried out on this surface, and it showed the presence of chromium and sulphur, all elements related to corrosive products such as iron and chromium oxides (Fig. 12, Tab. 1).

Figure 12: SEM analysis. Pit surface. – 60 X.

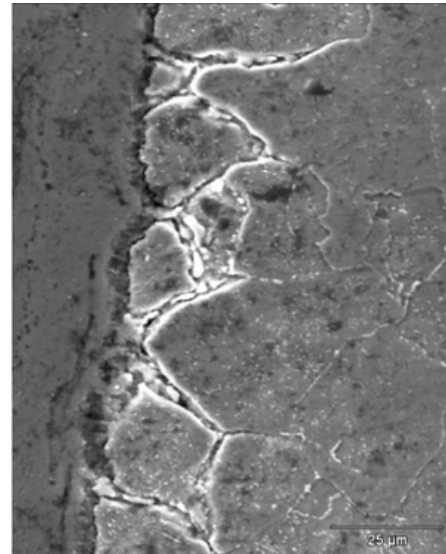
Considering the external pipe section scale: Fig. 16 shows a very porous and infiltrated surface, with relevant penetration of grain boundaries (Fig. 17).

Figure 16: SEM analysis. External pipe section scale – 350 X.

Figure 17: SEM analysis. Magnification of a detail from Fig. 16. – 1300 X.

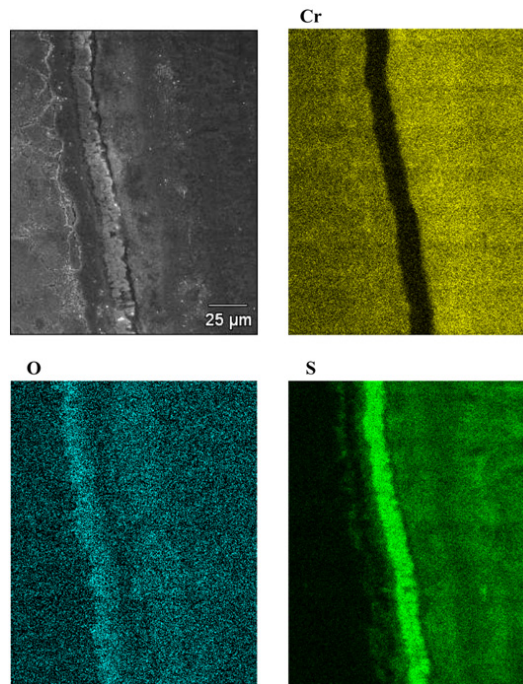
A map has been executed on a section of the scale (fig. 18). The map shows sulphur presence (sulphur compounds) at the interface between compressed and porous scale with a build-up immediately behind the compacted scale. A major Cr concentration appears in the penetrated area, while the oxygen is diffused.

Figure 18: SEM analysis. Map of corrosion crust – 800 X.

It shows sulphur presence (sulphur compounds) in all non homogeneous scale, and a build-up immediately beyond the compacted one.

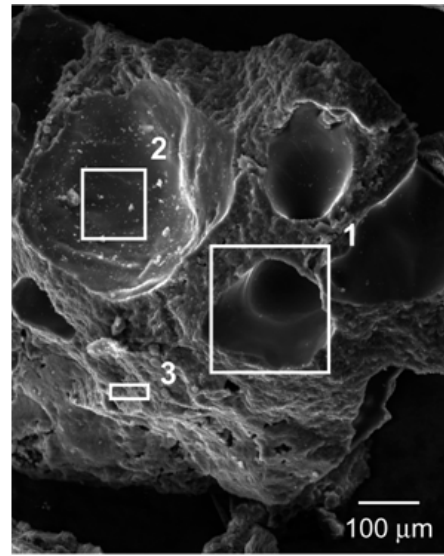
The pipe surface scale was examined (Fig. 7 – sample 2 section): micrographic analyses have been performed on particles removed from the surface scale. The following figures show two different crust types. The first one (Fig. 19) appears to be non homogeneous and porous. Channels rich in chlorine and sulphur formed by pressured gas are visible (Fig. 20), EDS analysis (Tab. 3).

Figure 20: SEM analysis. Channels in the surface crust – 170 X.
