Failure analysis of boron steel components for automotive applications

Marco V. Boniardi, Andrea Casaroli, Laura Sirangelo

Sergio Monella, Michele Mazzola

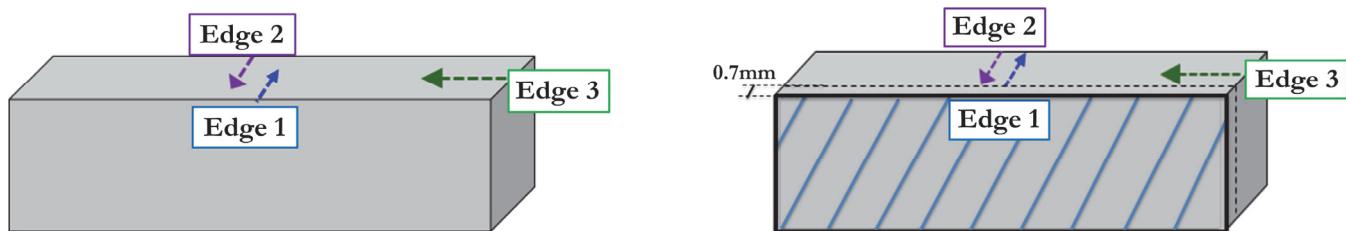
Figure 3: Analysed areas in samples from Set #1. Edges 1 and 2 correspond to the rolled surface; edge 3 corresponds to the area where the original rolled surface has been removed by fine blanking. In sample 1.1, edge 1 was ground to a depth of 0.7mm from the surface, while in samples 0.X no grinding was involved.

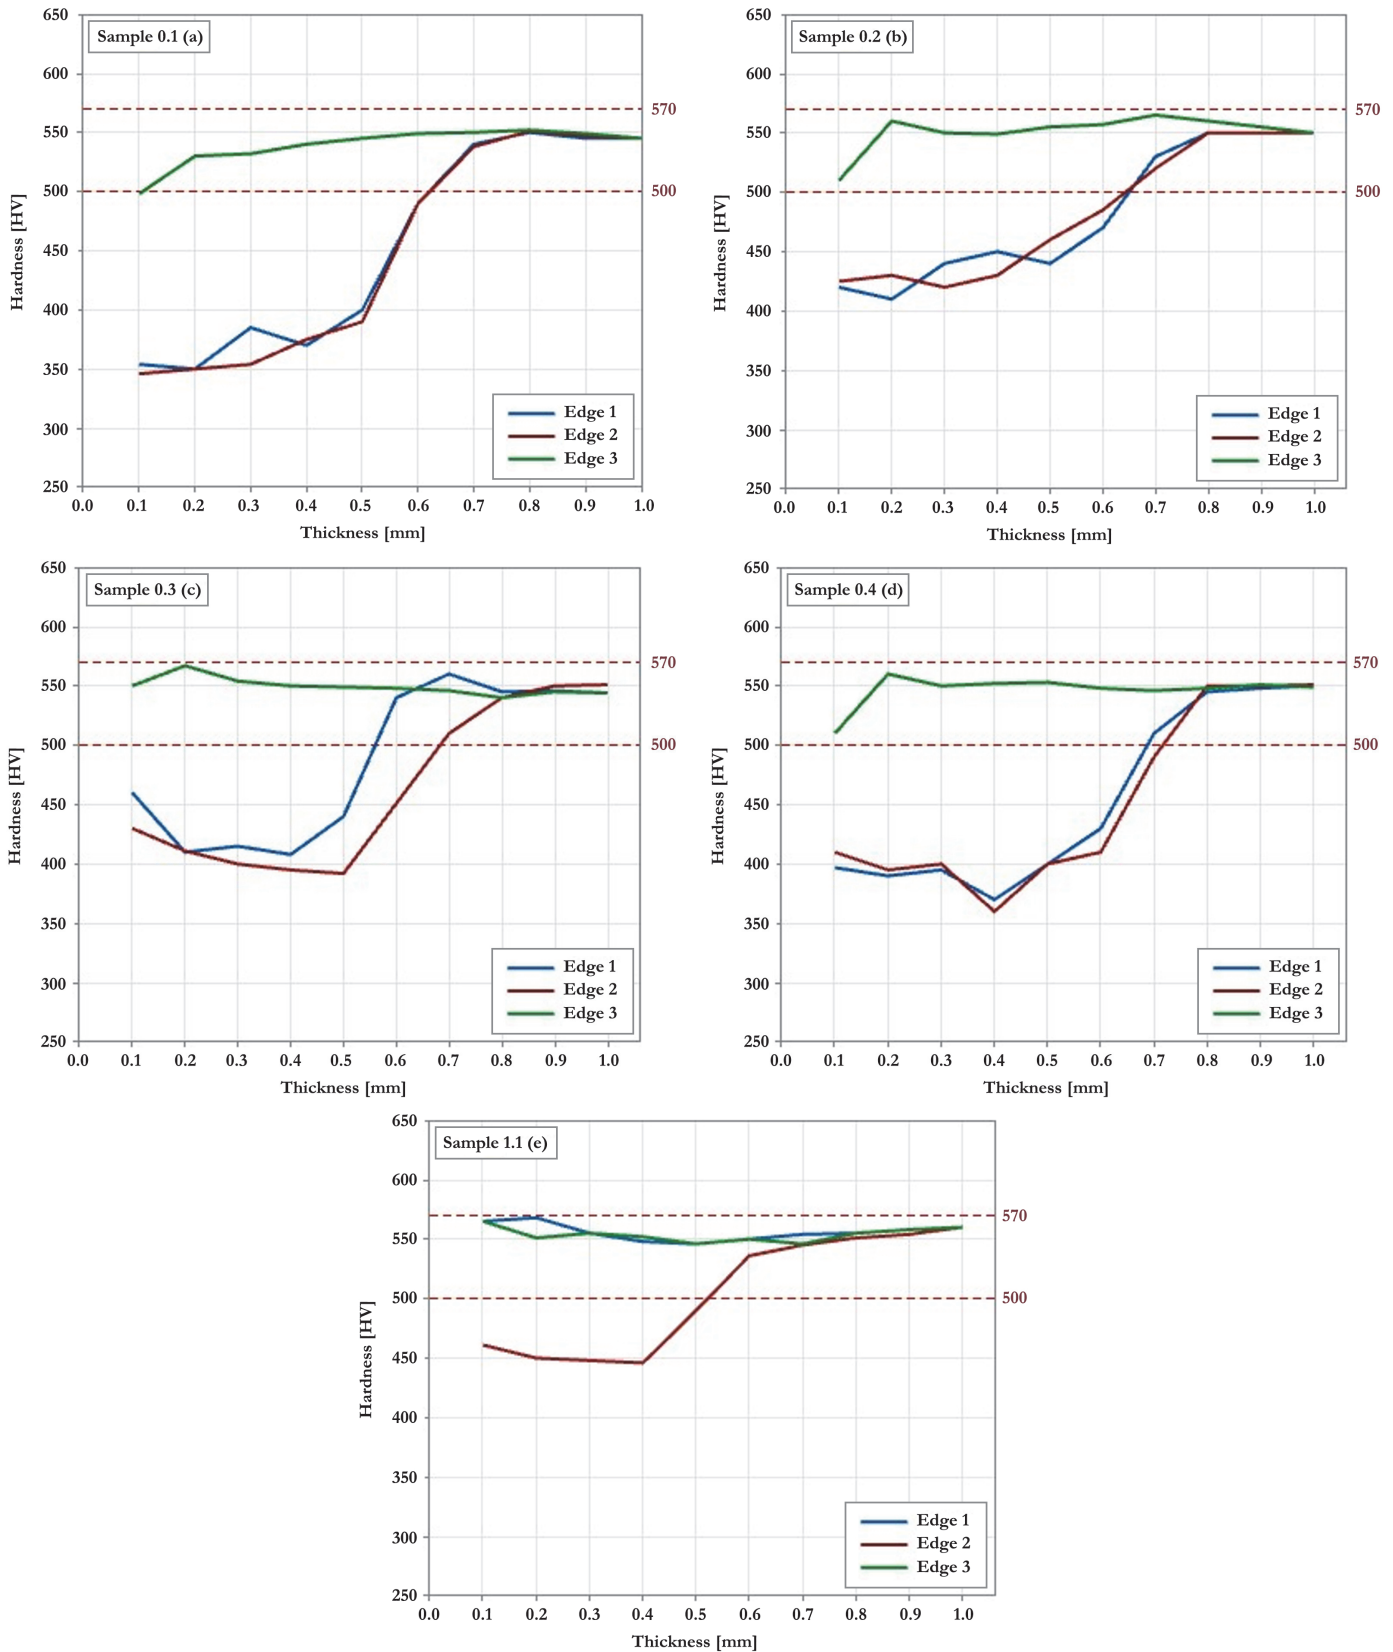
Fig. 4 shows the hardness values for the samples in Set #1. All 0.X samples exhibit a strong decrease in surface hardness (100-150HV) at the rolled surface (edge 1 and edge 2) to a depth of 0.5-0.7mm. On the other hand, only a minor hardness decrease is observed along the cutting edge (edge 3), where the original rolled surface was removed by fine blanking [10] before Q&T. The type of heat treatment has only limitedly affected the decrease in surface hardness. All 0.X samples are non-compliant even if the component has been Q&T twice (Fig. 4b) or if the Q&T process was preceded by spheroidize annealing at 700°C (Fig. 4d). Sample 1.1, instead, exhibits a different behavior. In this case, only edge 2 shows a hardness decrease, while edge 1, ground to a depth of 0.7mm from the surface before Q&T, is compliant all along its thickness (Fig. 4f). Furthermore, the loss of hardness at edge 2 is lower than in the previous case (< 100HV), which is due to lower thickness of the sample that (as already mentioned) was ground before Q&T. In these conditions, the quenching cooling phase is faster and heat treatment severity is more intense. Fig. 5 shows the micrographs of 0.X samples. The images highlight a layer of extremely fine ferrite and pearlite in the areas below the surface affected by the loss of hardness. On the other hand, areas far from the surface show only martensite. As expected, the layer of ferrite and pearlite is clearly visible under edges 1 and 2 while its thickness is low under edge 3. The metallographic analyses confirm what was observed from the micro-hardness of sample 1.1, i.e. ferrite and pearlite disappear completely along edge 1 while they are still present at edge 2.

Figure 4: Hardness vs thickness in samples from Set #1.

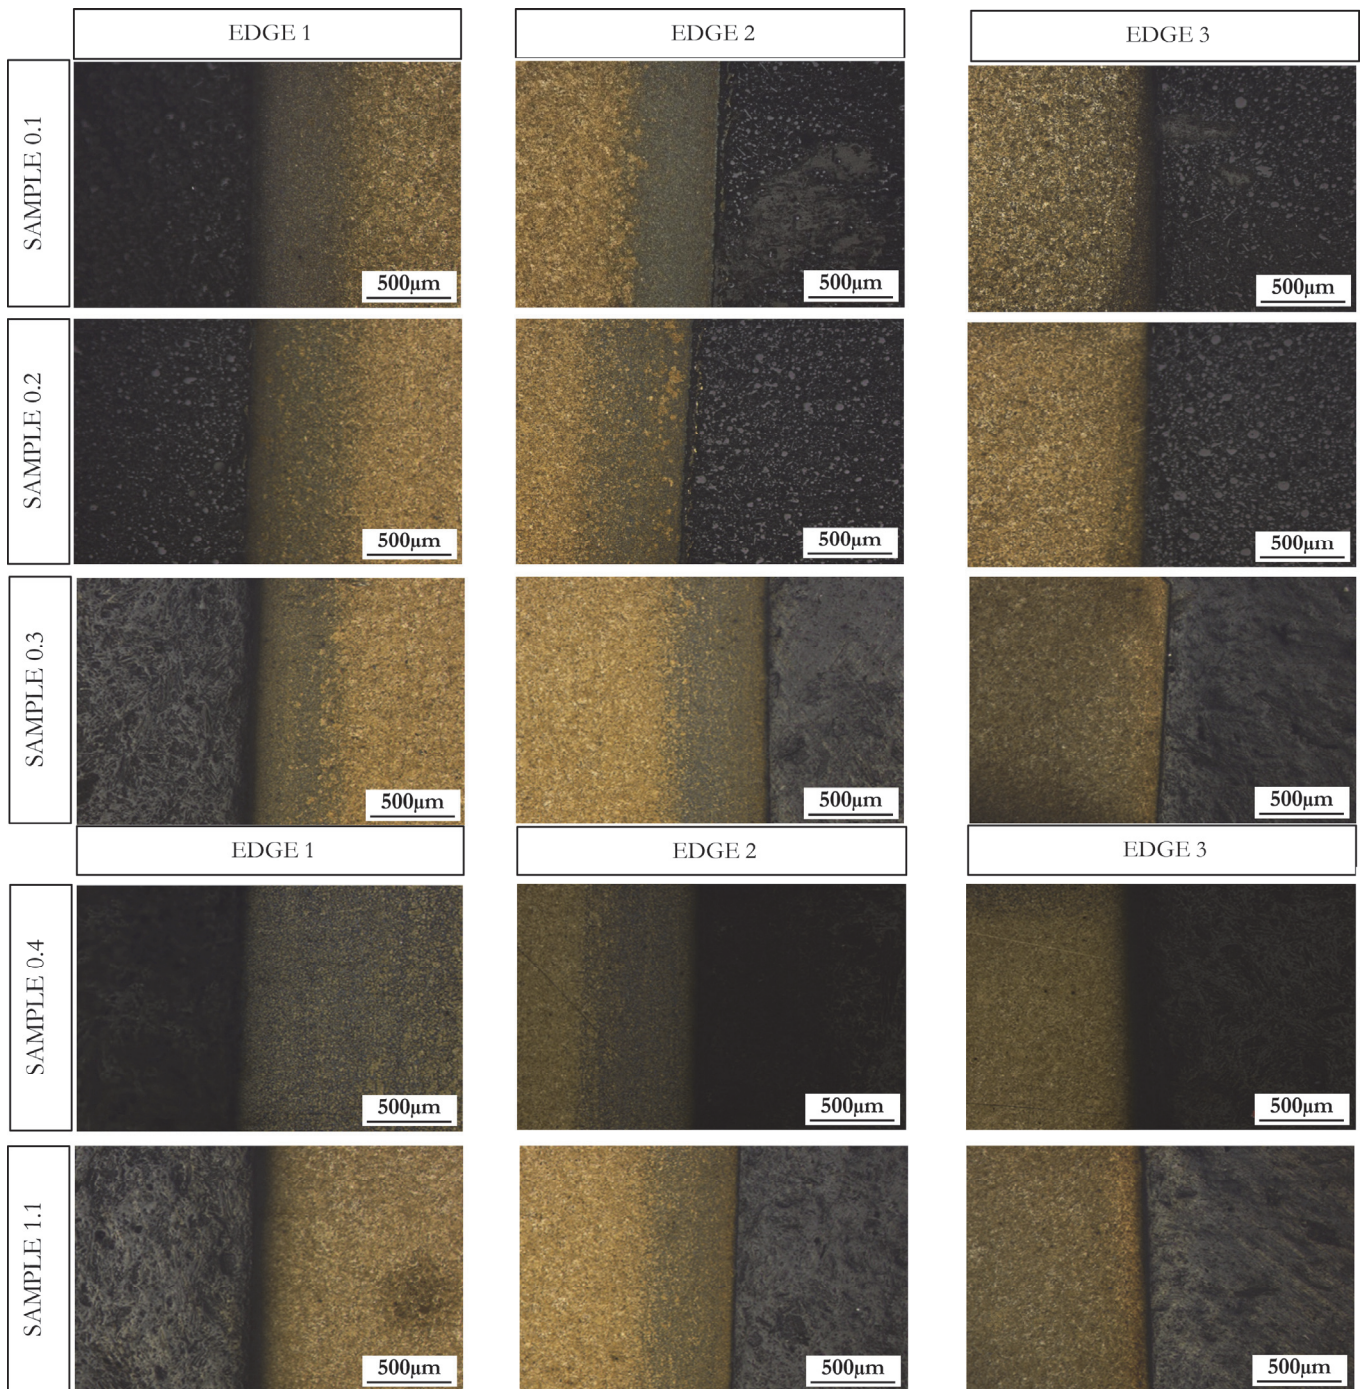
Figure 5: Micrographs of samples from Set #1 (etching agent: Nital2 - optical microscope). The images show the microstructure under the surface of edge 1, 2 and 3 of samples 0.1, 0.2, 0.3, 0.4 and 1.1 at low magnification (25x).

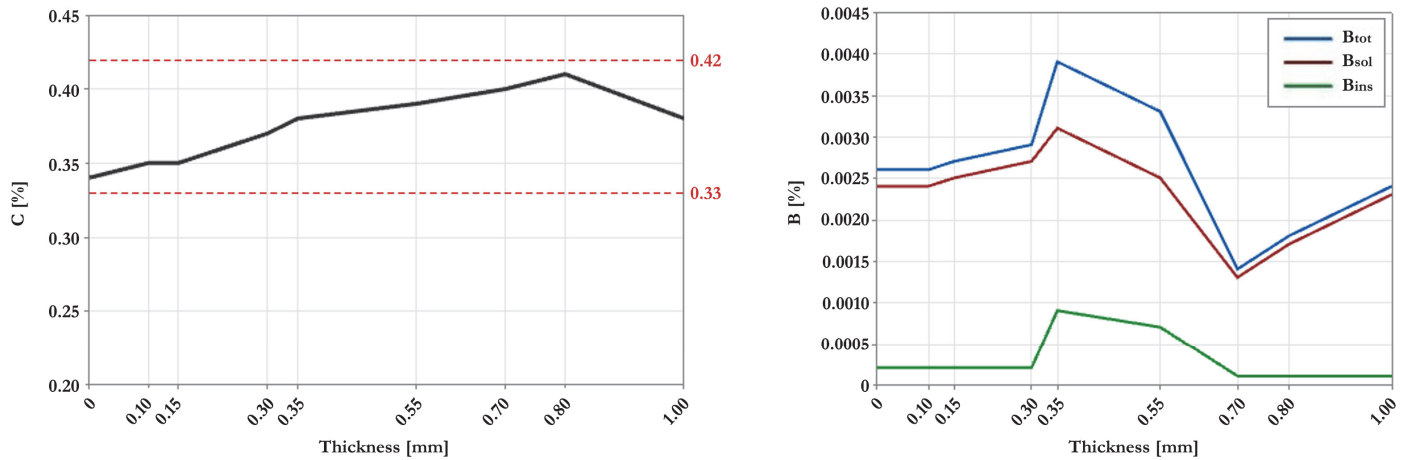
The carbon content is almost constant all along the thickness and there is no evidence of decarburization [11]. Compared to carbon, boron exhibits a fluctuating trend. Actually, it is quite stable (0.0025%-0.0029%) down to a depth of 0.3mm from the surface, then increases to about 0.0038% at a depth of 0.35mm and then sharply decreases (about 0.0015%) at 0.7mm from the surface. Below 0.7mm, boron stabilizes around the standard value (0.0025%) measured in the base material. Almost all boron is in solution in the metal lattice; only a negligible part of it is not in solution at a depth between 0.3mm and 0.7mm. In any case, the chemical analysis revealed a boron content higher than 0.0015% [4] that is the minimum amount required to activate the hardenability improvement in carbon steel.

Figure 6: Chemical analysis of sample 0.1; the images show the trend of carbon (left) and boron (right) along the sample thickness.

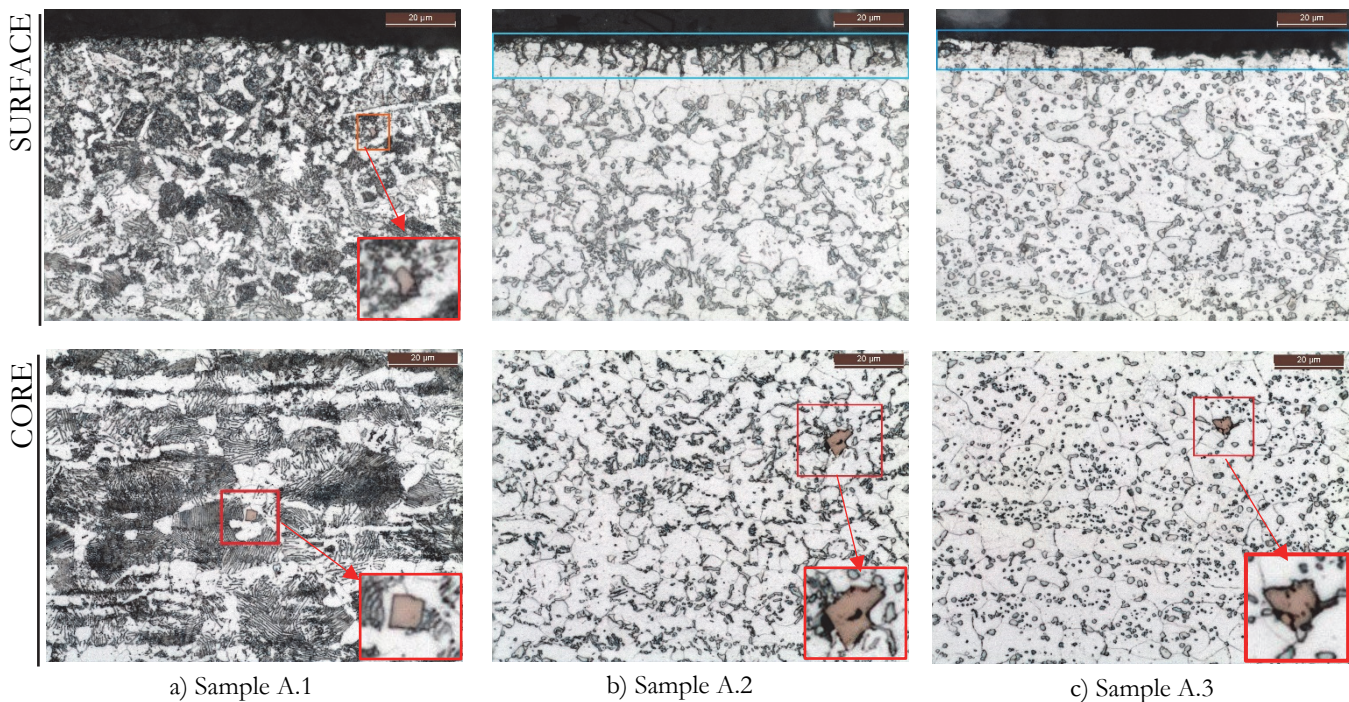
Fig. 7 shows the microstructure of A.X samples. Equiaxed grains of pearlite and ferrite characterize sample A.1 (As-Rolled + Pickling); the metallographies also show a small amount of titanium nitrides of micrometric dimension (1-5 μ m) along the entire thickness (red boxes in Fig. 7). These compounds still exist after the spheroidize annealing treatments (samples A.2 and A.3). Titanium nitrides observed in A.X samples are quite common in boron steel [12] where the titanium addition is performed to inhibit the formation of boron nitrides that would impair steel hardenability.

Figure 7: Micrographs of A.X samples (etching agent: Nital2 - optical microscope). The images show the microstructure below the surface and at the core of samples A.1, A.2 and A.3 at 1,000x magnification.

Samples A.2 and A.3 exhibit a thin oxidized layer (< 20 μ m) below the surface (light blue lines in Fig. 7), showing slight oxygen contamination of the H₂-N₂ protective atmosphere used for spheroidize annealing.

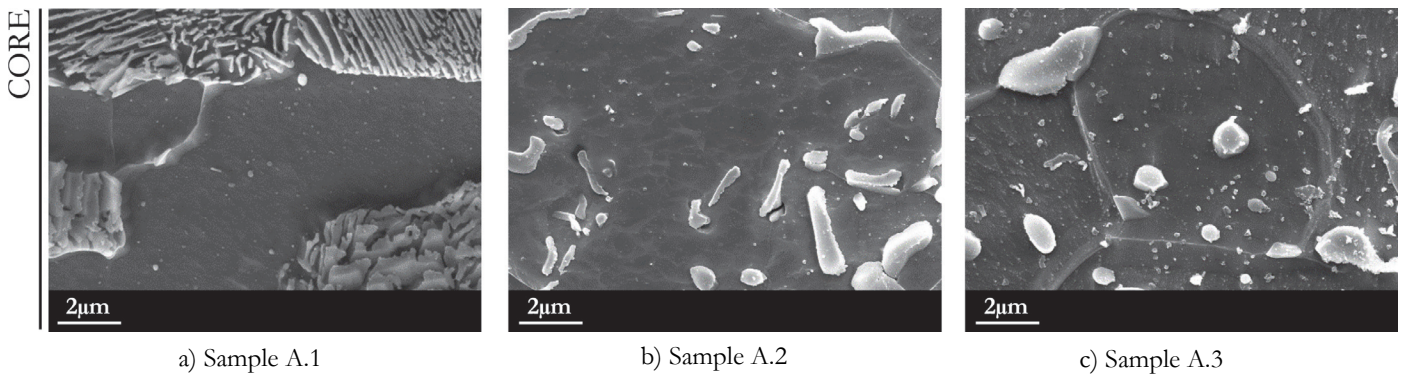
The SEM analyses of A.X samples (Figs. 8 and 9) reveal other types of compounds finely scattered both inside and at the boundaries of the ferritic grains. These compounds mainly consist of nitrides, carbides, or carbo-nitrides of titanium, aluminum or silicon with nanometric dimension (<< 1 μ m). The compounds are mainly localized below the surface (orange dashed lines and red boxes in Fig. 9) while they are almost absent at the core of the sample. Metallographies show that nanometric compounds increase sharply after spheroidize annealing heat treatments.

Figure 8: Micrographs of A.X samples. SEM analyses at the core (magnification: 20,000x - etching agent: Nital2).

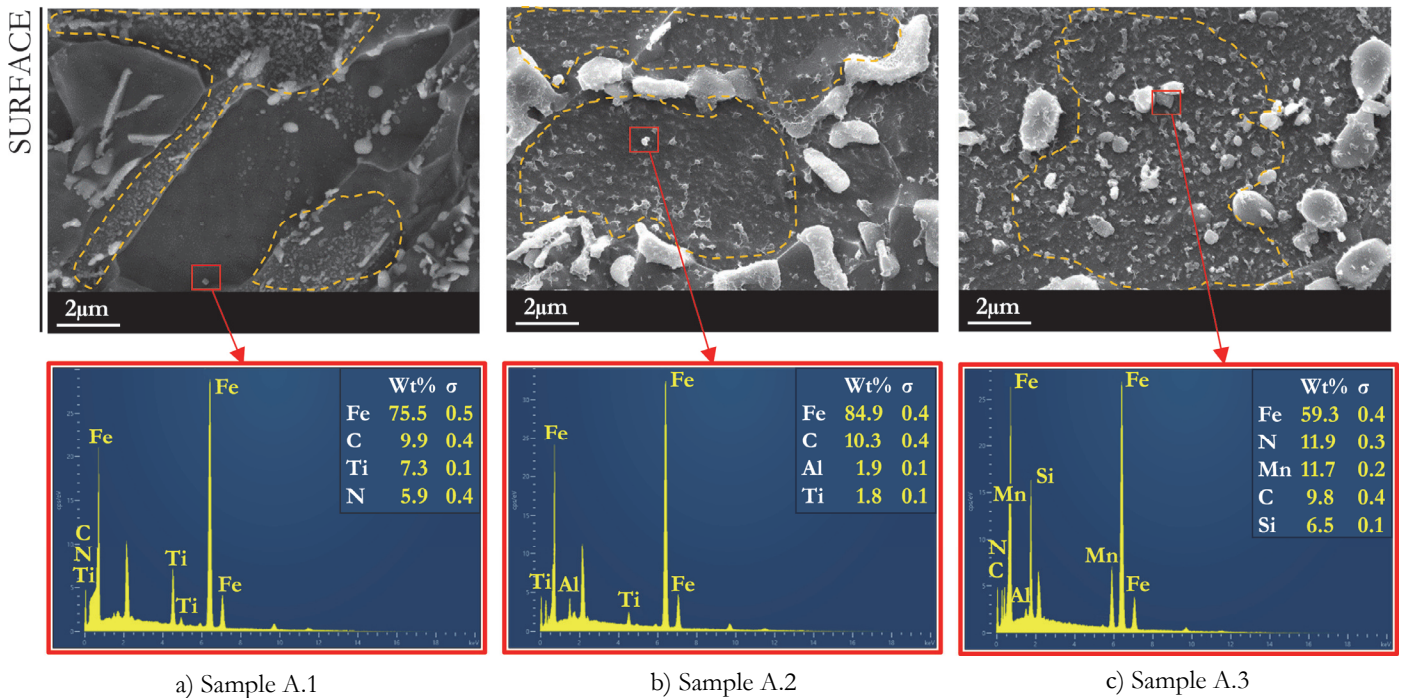
Figure 9: Micrographs of A.X samples. SEM analyses at 0.2mm depth from the surface (magnification: 20,000x - etching agent: Nital2). The orange dashed lines highlight areas characterized by nanometric compounds. The red boxes indicate the compound chemical analysis.

Nanometric compounds do not dissolve at quenching or spheroidize annealing temperatures (880°C and 700°C, respectively) and act as nucleation sites for new grains when heat treatments exceed steel critical points. The great number of nucleation sites causes strong grain refinement and decreases hardenability beneath the surface.

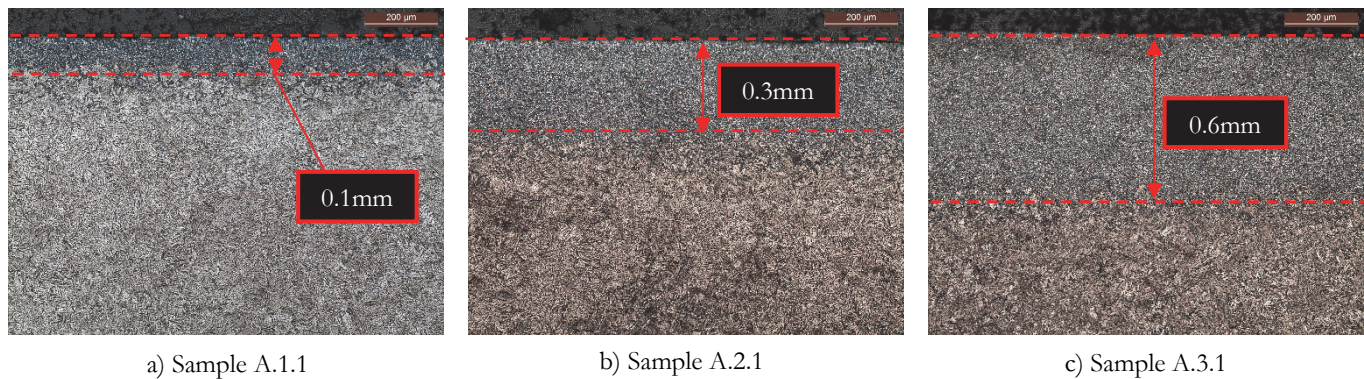
Finally, Fig. 10 shows the samples after the Q&T treatments. As expected, the layer of very fine ferrite and pearlite already found in the samples from Set #1 is also present in samples A.1.1, A.2.1 and A.3.1 (red dashed lines in Fig. 10). This layer

is negligible (0.1mm depth) in sample A.1.1 where it causes a limited hardness decrease equal to 50HV (Fig. 10.a). Sample A.2.1 shows a deeper layer of ferrite and pearlite (down to 0.3mm) and a more considerable loss of hardness, about 100HV, not compliant with the minimum hardness requirement (Fig. 10.b). Sample A.3.1 shows a loss of hardness and thickness of the ferrite and pearlite layer that are even worse than in sample A.2.1. The decrease in hardness is about 150HV and the layer depth is about 0.6mm.

Figure 10: Micrographs of A.X.1 samples after Q&T (etching agent: Nital2 - optical microscope). The images show the microstructure below the surface of samples A.1.1, A.2.1 and A.3.1 at 200x magnification.

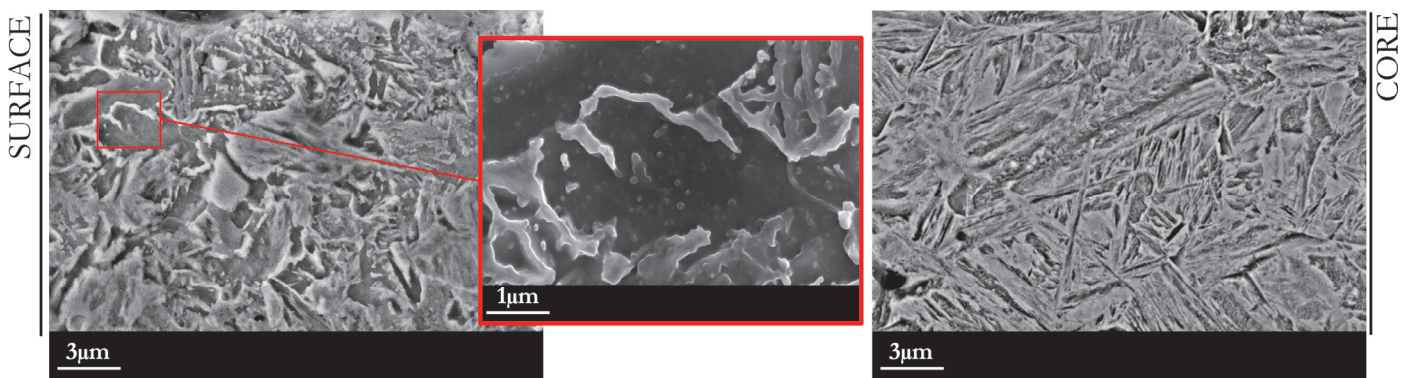
The SEM analysis of sample A.3.1 confirms that martensite transformation does not occur beneath the surface where the nanometric compounds inside the ferrite grain are still present after Q&T while the core of sample A.3.1 is composed exclusively of martensite.

Figure 11: Micrographs of A.3.1 samples (magnification: 10.000x – etching agent: Nital2). SEM analyses below the surface (left) and at the core (right).
