## Numerical analysis of repaired wall loss defect pipelines for optimum composite wrap thickness

**ABSTRACT.** This paper presents the numerical analysis of failure pressure of wall loss defect metallic pipelines and validate it with experimental results. An optimization study is carried out using developed numerical model to propose the optimum composite repair thickness for cost effective repair system. A nonlinear explicit FE code with constitutive models for metallic steel and composite material to failure modelling was used. Three different cases: non-defective pipe, wall loss defective pipe and composite repaired of defective pipe are considered. It was found that the numerical results are in good agreement with the analytical results in all the three cases. Numerical results of composite repaired pipe were verified with hydrostatic test and both failure pressure and failure location closely matches, however the failure pressure determined by standard ISO/TS 24817 is too conservative for the same repair system. The optimization results revealed that even with reducing 40% of composite thickness with respect to the ISO/TS24817 standard, the repair system can sustain the desi

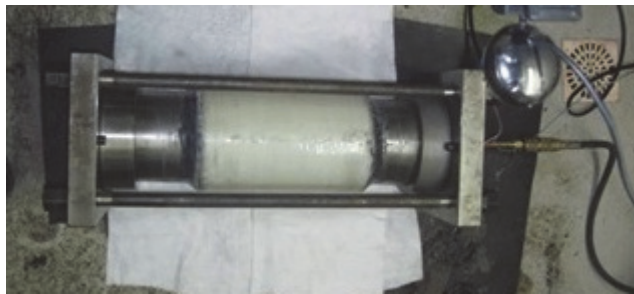
Figure 1: Repaired wall loss defect pipeline specimen for Hydrostatic test.

Tab. 2 presents the geometrical dimension of wall loss defect API 5L X56 steel pipe. The length of pipe specimen is 600 mm and repaired length 300 mm which is half of the pipe length. Composite wrap (glass fibre reinforced) of 16.2 mm thickness calculated based on the design code ISO/TS 24817 is applied over defect region of pipe. Repaired wall loss defect pipeline is as shown in fig. 1. A well detailed hydrostatic test procedure and parameters are explained in [4]. The pressure curve of the hydrostatic test for repaired pipe is presented in Fig. 2. The repaired pipe with 16.2 mm composite thickness sustained the original design pressure of 32.3 MPa.

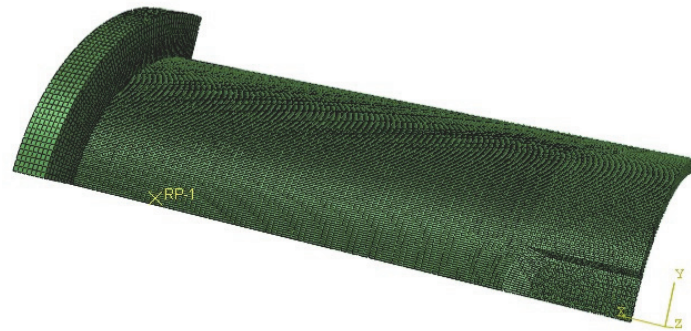
Figure 5: Finite element model with fine mesh of 0.82 mm element size.

The mesh size effect on results has been validated using mesh size convergence. The mesh size used in the analysis is 2.8mm at the critical areas. The results were validated with a very fine mesh size of 0.82 mm and the deviation observed was 3% (see Fig. 5). The number of nodes and elements of each case is shown in Tab. 3.

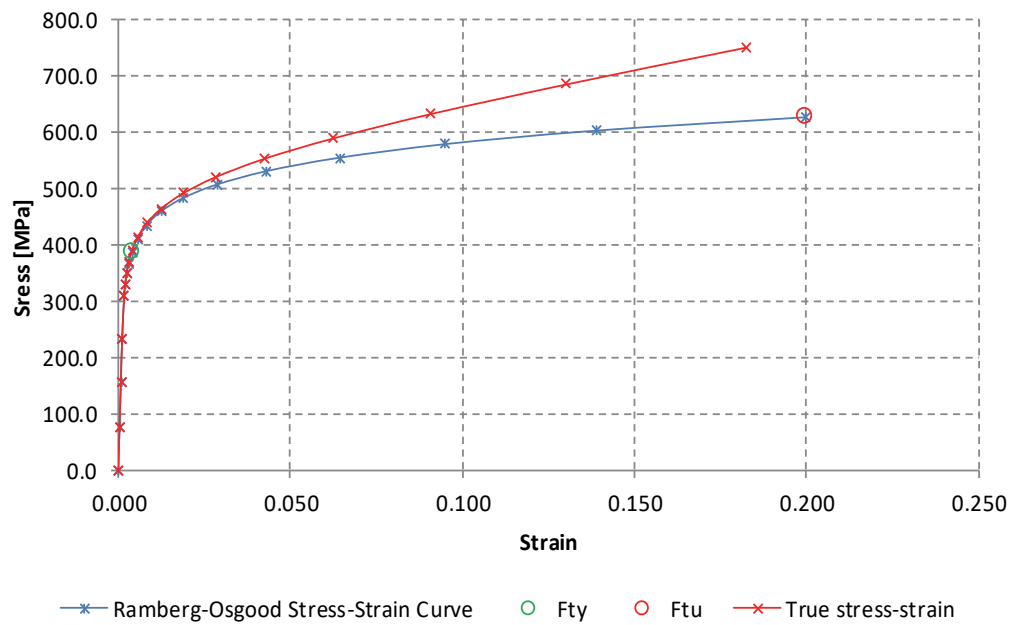
Figure 7: Stress-Strain curve of steel pipe.

The maximum sustained failure pressure of pipe can be determined from the above simple equation with considering the maximum yield strength of pipe as an allowable stress. The maximum failure pressure obtained ( $S_a = \sigma_y = 386 \text{ MPa}$ ) from analytical formula is 32.61 MPa for the steel API-5L X56 pipe thickness of 7.11 mm and diameter of 168.3 mm (Tab. 2). The failure pressure obtained from numerical model is 34.6 MPa for the same configuration. It is clearly noticed (Tab. 4) that the numerical results are closely match with the analytical failure pressure with an acceptable error limit of 6%. The result of numerical analysis of von Mises stress of steel pipe without defect is shown in Fig. 6 and it shows that the pipe is experiencing a maximum 386 MPa stress for failure pressure of 34.6 MPa. Fig. 7 shows the true stress-strain and Ramberg-Osgood stress-strain curve of API 5L X56 Steel.

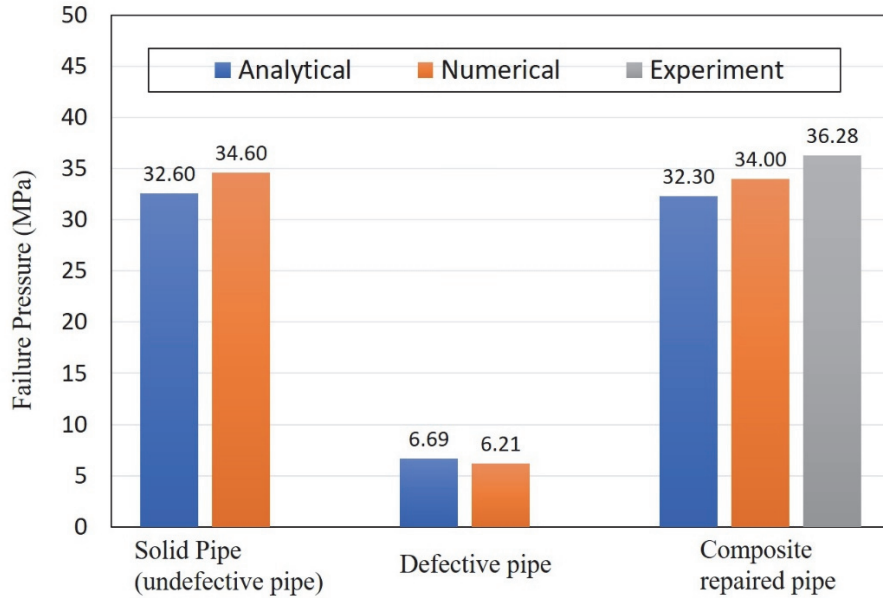
Figure 14: Failure pressure of metallic pipe of three different cases

Fig. 14 shows the numerical and analytical failure pressure obtained in all three cases and it clearly shows that the results are closely matches. Pipe extremities condition, plastic behavior are the possible causes for the failure differences between experimental and analytical using ISO/TS24817 standard [37]. However, the failure pressure of repaired pipe obtained analytically (ISO/TS 24817) is lower as compared to the experimental failure pressure, but this will keep more margin and which ultimately safer but with the cost of more composite material and this urge to optimize the composite repair thickness for cost effective repair.

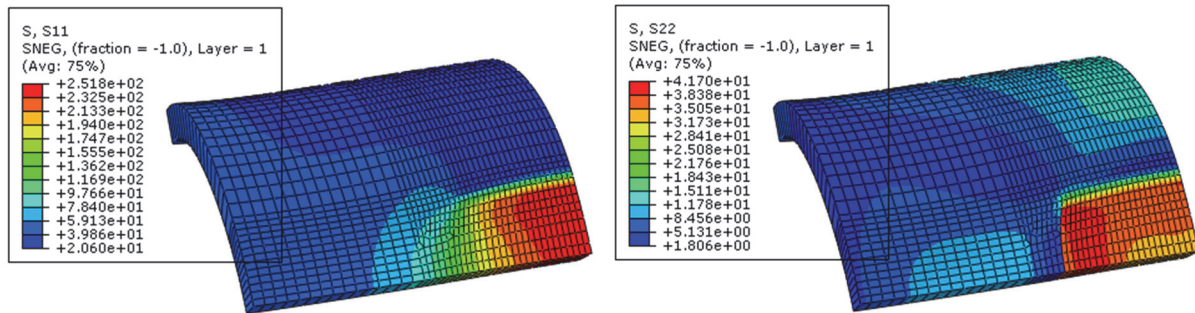
Figure 16: Hoop Stress, 252 MPa and Axial Stress, 41.7 MPa developed on composite wrap.

It is concluded from the last section that the numerical and experimental results of repaired pipe can sustain the designed pressure without any failure sign on the composite repaired section (Fig.13a and b). This implies that repaired pipe can sustain more pressure than the calculated pressure using ISO/TS 24817 standard before failure of repaired pipe. A von Mises failure criterion is used to define the failure in the steel pipe and putty, while Hashin's failure criteria used for composite failure (Eqn. 1, 2 & 3). As a numerical result, the pipe sustained maximum pressure of 46.7 MPa which is 30% higher than the obtained failure pressure as per design standard. Margin of safety is +0.01 (1-0.99) as shown in Fig. 15 with applied pressure of 46.7 MPa. It is found that the observed hoop stress of 252 MPa and axial stress of 41.7 MPa (Fig. 16) which is close to the allowable stress. The higher composite thickness makes composite wrap more stiffer and which lead to plastic deformation in steel pipe as shown in Fig. 17. However, it is not advisable to put maximum pressure as a design pressure for the repaired pipe, as there would chance to fail steel pipe before composite failure in defect section. Therefore, composite thickness should be optimum in such a way that there should not be plastic deformation in pipe and composite wrap should not behave as a rigid body.

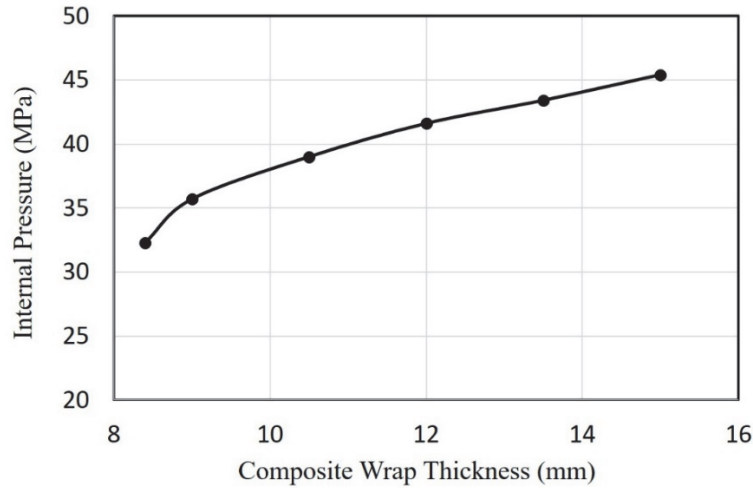
Figure 18: Internal pressure for composite wrap thickness

As present composite repair system sustained 1.5 times of design pressure, so scope of composite optimization is relevant. As part of optimization, different thickness has been considered with same weight proportion on longitudinal and lateral direction (the maximum burst pressure for different thickness has been shown in Fig. 18). It can be seen that with an increase in composite repair thickness the sustained internal pressure also increased and it obviously as the more material available to resist. However, there is no point to increase the thickness of composite wrap, as there is cap for upper maximum internal pressure of solid pipe. Therefore, it is very important to optimize the composite repair thickness in terms of economical repair system with keeping design pressure as the upper limit.
