## Experimental work of effect of openings on the post-tensioned flat slab

**Citation:** Zamrawi, A., Shoeib, A., Ibrahim, A., Ahmed, S., Experimental work of effect of openings on the post-tensioned flat slab *Frattura ed Integrità Strutturale*, 67 (2024) 292-310.

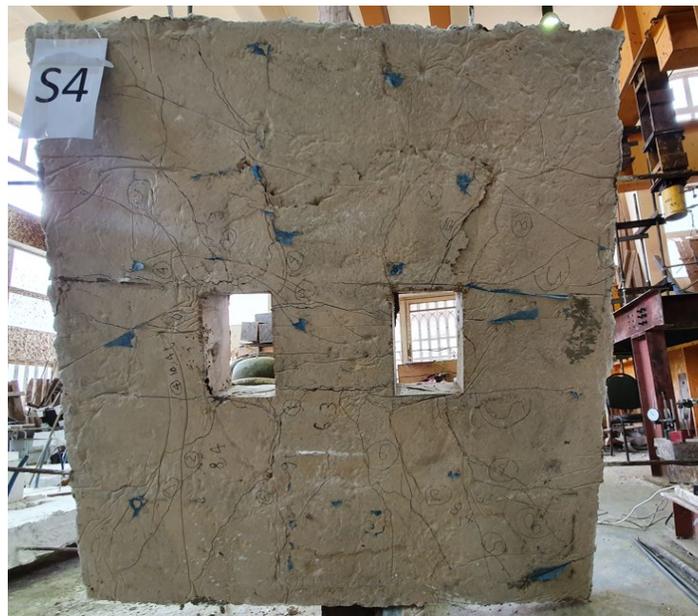
Figure 1: This slab shows us the form of punching failure and cracks if there are two holes next to the column.

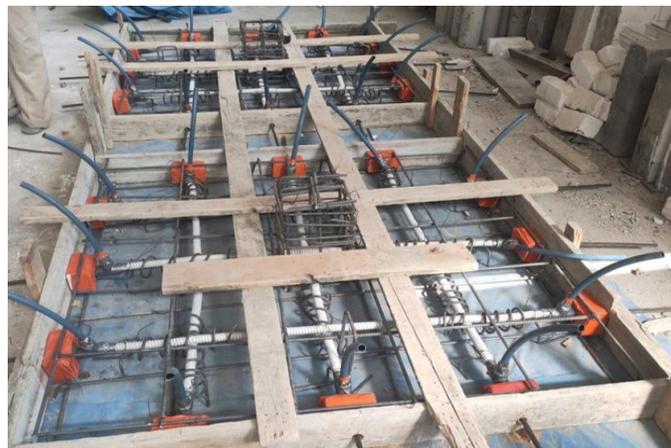
Figure 3: Details of reinforcement steel.

The experimental test specimens were made of concrete that was cast in Egypt using local components. Ordinary Portland cement was used for the cement, and siliceous sand and nice, clean, well-graded dolomite made up the fine and coarse aggregates. As the primary reinforcement steel, 10 mm diameter high tensile steel bars were used. Three randomly chosen samples of bars from each batch were used to test the qualities of reinforcing steel bars based on the findings of the tension tests. All specimens' primary steel was subjected to strain measurements using internal electrical strain gauges (Type KFG-10-120-C1-11), the gauge length was 10 mm, the resistance was 119.8 0.2 ohms, the gauge factor was 2.11 1%, and the transverse sensitivity was 0.2%, as shown in the Fig. (3).

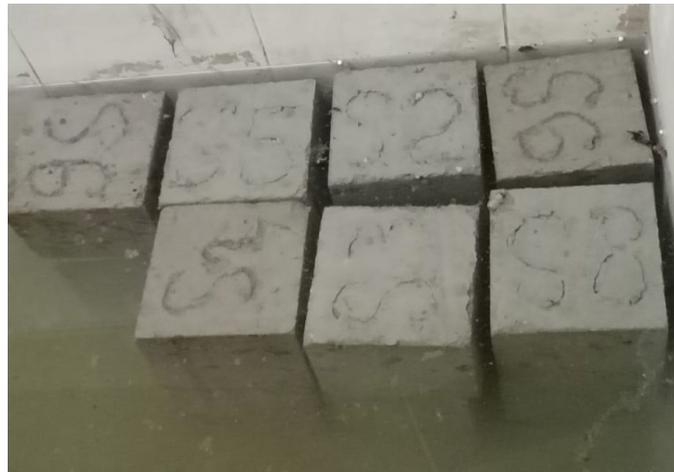
Figure 4: Standard cubes (150 x 150 x 150 mm), while immersed in water.

In order to mix, a concrete drum mixer was used. Sand, aggregate, and cement were first carefully mixed without the addition of water until they had reached a uniform color. After adding the water, the mixing process went on for another three minutes or so until a consistent tint was achieved. The specimens were covered with wet burlap sheets to cure the concrete after it had been poured in the molds and fully compacted using a vibrating table. For each slab specimen, two standard cubes (150 x 150 x 150 mm) were cast and tested to establish their compressive strength. To ensure complete curing, all specimens were immersed in a basin of water, (see Fig. 4), for seven days after being remolded after 24 hours together with the sides of steel shutters. The average compressive strength for cubes was 34.5 MPA for the mix, as shown in the Fig. (4 and 5).

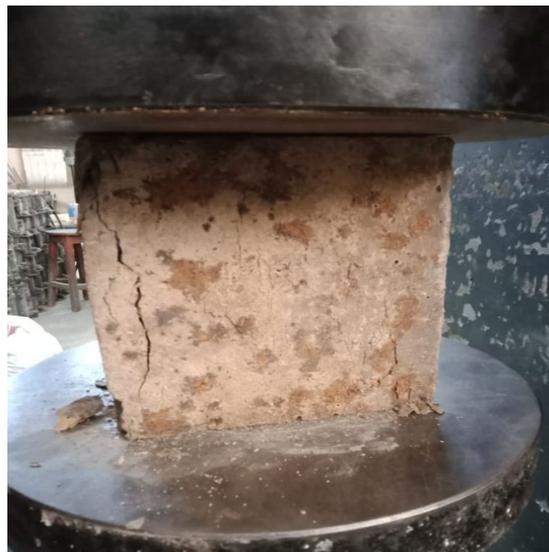
Figure 5: The shape of the cracks in the test cubes on the crushing machine.

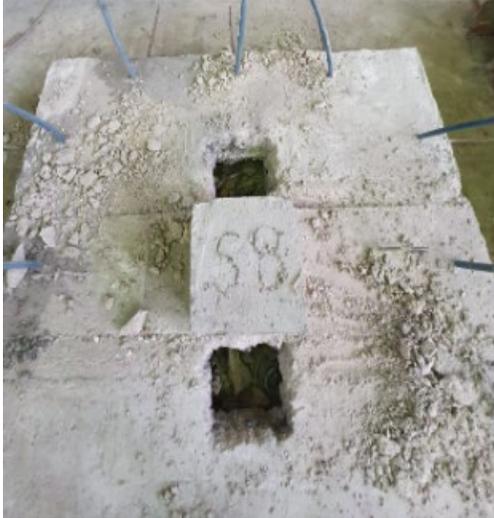
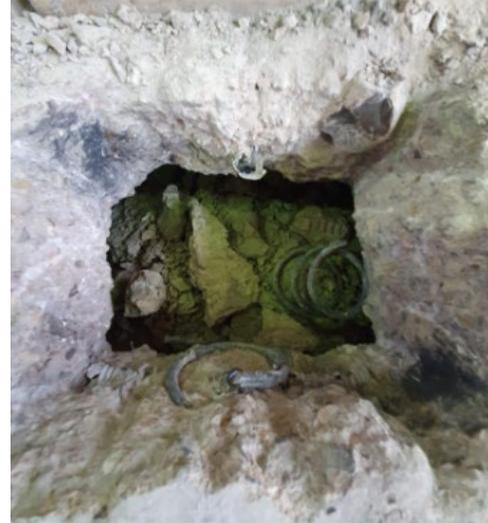
Figure 6: (S 8) After making the two holes and cutting the strand. Figure 7: A picture to illustrate the shape of the opening after casting, as well as the cut strand after tension.

- After 28 days, the cubes were tested.
- Grout injection after 29 days through Grout vent.
- After 32 days, the Strands were injected.
- Then the Strands were tightened.
- Making openings in slabs, and Strands Cutting (S6, S7 and S8), as shown in Fig. (6 and 7).
- Samples were prepared for testing.

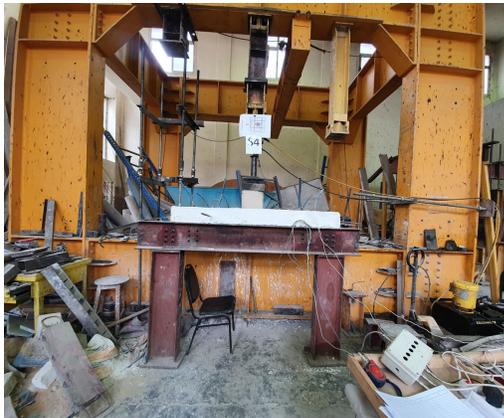
Figure 8: Test Setup for the loading machine on the slab.

The head bearing plates on the jack heads were modified to prevent any eccentricity from incorrect positioning or column head leveling, ensuring that the load eccentricity was maintained throughout the loading process. The hydraulic jack, coupled to a manual pump to supply oil pressure, and the system of plates and rollers that allowed rotations at the top end of the column were the components of the column axial loading system, as illustrated in Fig. (8, 9 and 10).

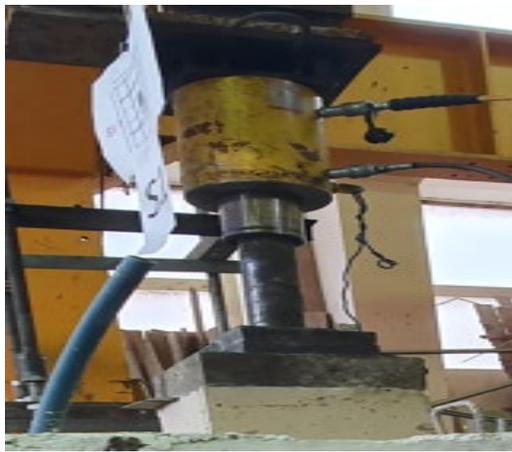
Figure 10: A metal plate between the jack of the loading machine and the concrete.

A metal plate must be placed between the jack of the loading machine and the concrete column to distribute the machine load on the column and then on the slab.

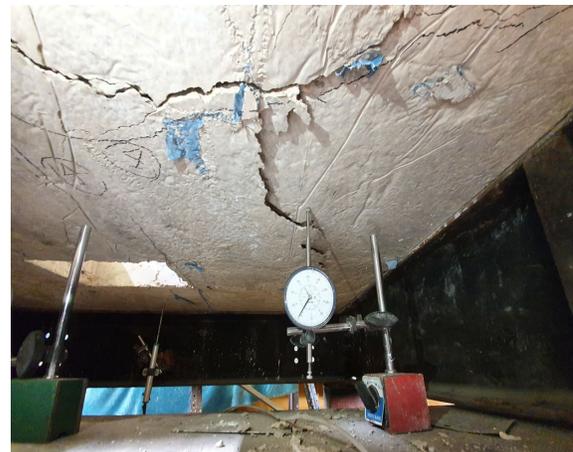
Figure 11: LVDT to measure slab deflections.

The electrical load cell, electrical pressure sensor, and LVDTs, as illustrated in Fig. (11), that measure slab deflections were all continuously read by the data acquisition system. Electrical strain gages measurements were recorded at the displacement maxima, and the system paused for 10 seconds to allow crack monitoring. Readings after failure loads (the unloading zone) of up to 25% of the maximum loads were obtained for some specimens. This procedure was carried out manually utilizing variable load increment because the machine lacked displacement control capabilities.

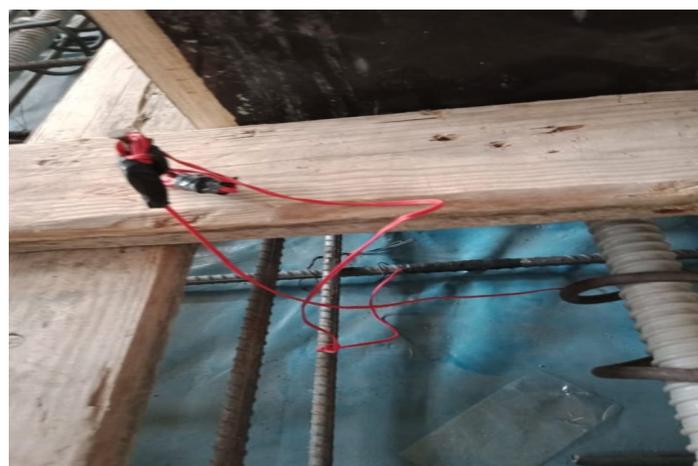
Figure 32: Strain Gauges it was installed on a slab reinforcement.

Stress values were obtained by installing a Strain Gauges, on the bottom reinforcement mesh of the slab while it was in a position with the column from above; Strain Gauges is the red cable is next to the column, As shown in the Fig. (32 and 33), and the strain values are also shown in Tabs. (8 and 9) which were read using Strain Gauges.

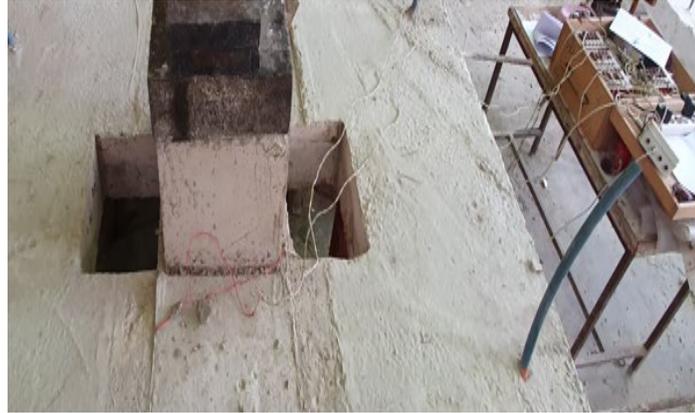
Figure 33: The Strain Gauge “red cable” is connected to the white cable of the Device for reading Strain results.

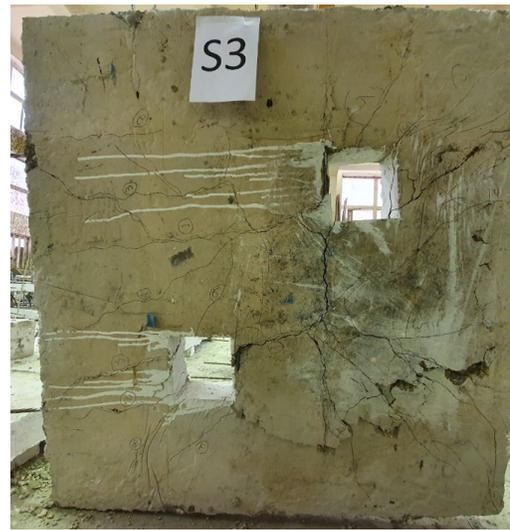
Figure 35: Punching failure surfaces of post tensioned flat slab Openings, (S3).

The post-tensioned flat slab specimens were tested till failure, and the tests were stopped when the punching cone surface was clearly formed at the bottom surface of the slab. The failure was initiated with longitudinal hairy cracks that started from the column faces to the slab edges. Then gradually the punching cone surface was formed around the column edges, while increasing the load the major crack of punching cone width was increased till the crushing of concrete around the punching cone surface. Fig. 23 shows clearly that the specimen exhibited a brittle punching shear failure. The crack pattern is marked in black during the loading of the slab. The appearance of cracks during increased load on the slab was numbered.

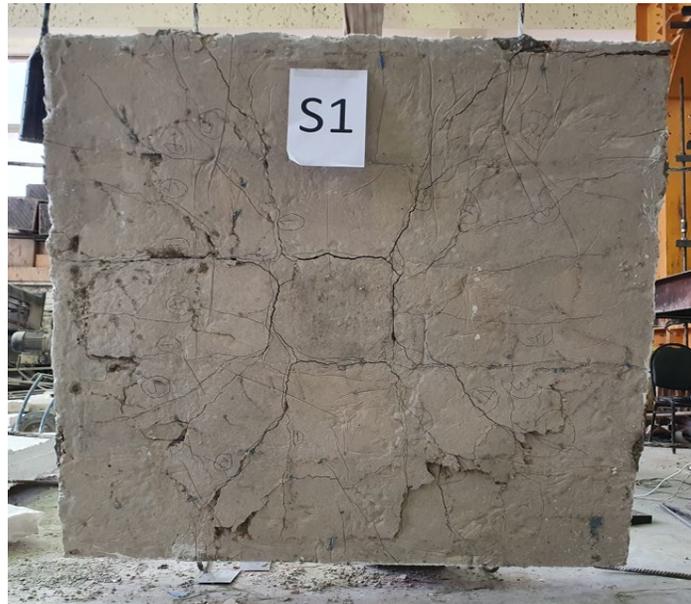
Figure 30: Failure Mechanism of the Post-tensioned Flat Slab during experimental tests. The appearance of cracks during increased load on the slab was numbered.
