Structural integrity analysis of the pre-stressed concrete dome of the Belgrade fair hall 1

Frattura ed Integrità Strutturale – Fracture and Structural Integrity

KEYWORDS. Belgrade fair hall 1, Structural integrity, Pre-stressed concrete, Numerical simulation.

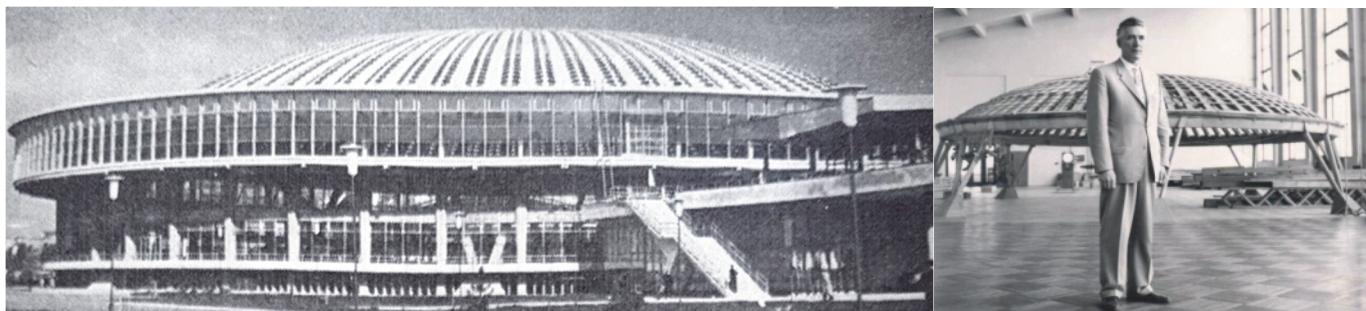
Figure 1: a) Belgrade fair hall 1, b) model 1:10 with Branko Žeželj in front of it [6].

Belgrade fair hall 1, is the exhibition hall of the Belgrade Fair, and with height 27.8 m and diameter 106 m, Fig. 1a. The outer outline of the hall is made of upper peripheral galleries, at heights of 4.7 and 8.7 m. The hall is surrounded by glass walls with a diameter 117 m. It comprises the dome and supports, bearing the roof dead load, with a 97.5 m diameter; the gallery and its supports; and the basement and ground floor [7]. Central circular cap is slightly convex and double plated with thickness 8 cm each and whose surfaces are connected by circular and radial ribs.

It was designed by a team comprising an architect Milorad Pantović and civil engineers Branko Žeželj, Boško Petrović and Dimitrije Čertić, and tested using the model 1:10, Fig. 1b, [7]. After testing of the Hall 1 1:10 model, the following was concluded, [7]:

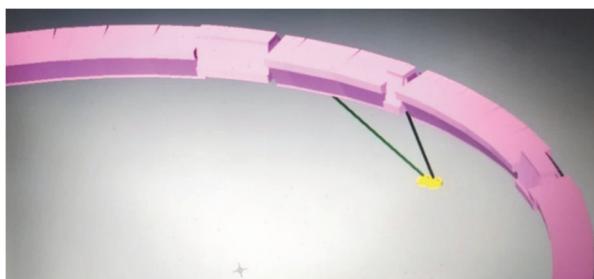
Figure 3: Different orientations of local coordinate systems in a 3D representation of support ring.

Due to potential problems related to TOWER software during simulation of complicated pre-stressing loads, especially if geometry is not symmetrical one, a cross-section of the support ring was adopted in a way as close to the real one as possible, which can be seen in Fig. 2. In addition, a local coordinate system (LCS) had to be adopted, wherein vertical plate bending of the support ring corresponded to bending about the second axis. Considering that the adopted cross-section of the support ring was not symmetric, one part of the support ring had one coordinate system, whereas the other part had its own coordinate system, which is rotated by 90 or 180° (or by any other angle) relative to the first one, as shown in Fig. 3.

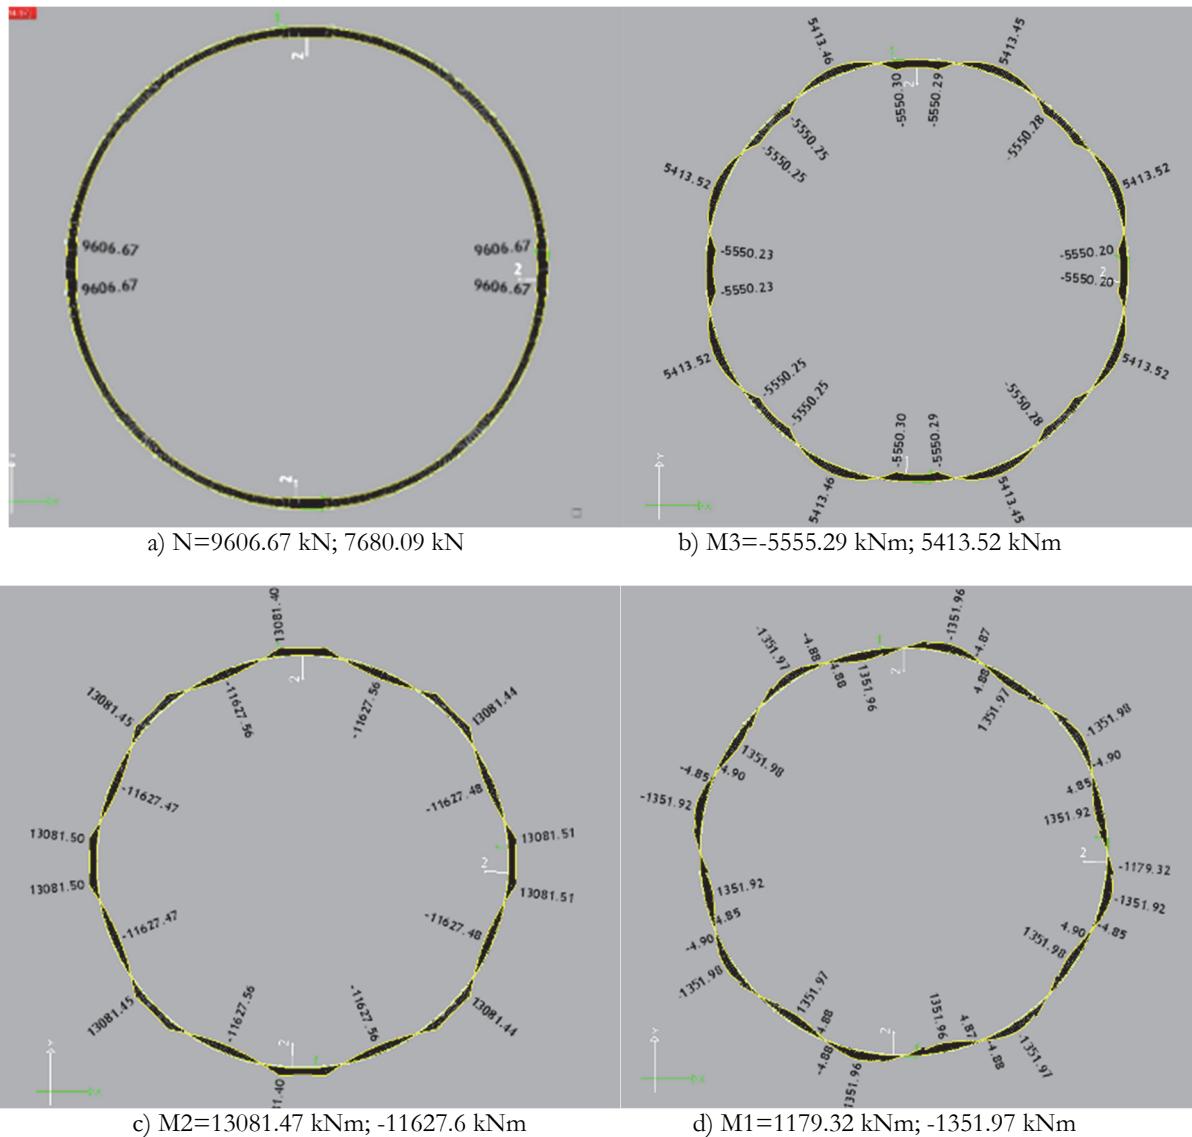
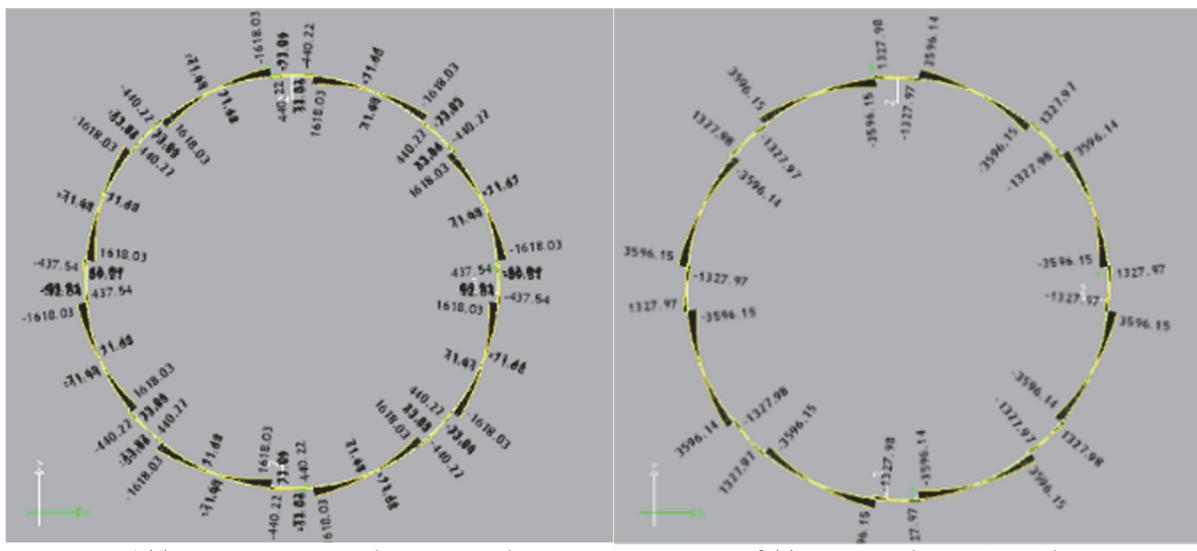
e) $T_2=440.22; -1618.03 \text{ kN}; 0; 71.68 \text{ kN}$

f) $T_3=1327.98 \text{ kN}; -3596.15 \text{ kN}$

Figure 4: Results for load case 23.

Results of calculations by TOWER software are presented in Fig. 4 for load case 23 and in Figs. 5-6 for load case 24. In Fig. 4a one can see that the higher tensile force is in the ring sections above the “V” columns. Normal force ratio in the ring is $9606.67/7677.12=1.25$. Tensile force due to dead load of the dome and snow in the sections above the “V” columns

is 25% higher than the forces in the full span. Maximum value of normal force is shown in Fig. 5. In Fig. 4b one can see that the moment values in the horizontal plane in sections above "V" columns and in the full span are very similar, with a difference of only 2.6% - $5555.29 / 5413.52 = 1.026$ (according to Žeželj, values were 5330 and 5360 kNm, [4]). In Fig. 4c one can see that values of maximum moments in the vertical plane in ring sections above "V" columns and the full span, are very close (12.5% difference), $-13081.47 / 11627.6 = 1.125$, although of opposite directions. In Fig. 4d one can see that the peaks above all columns are 942.47 kNm; Values immediately before these peaks are 776.98 kNm.

In the load case 23 one can see that the compressive force N is larger above the “V” columns, whereas the M_3 moment above all columns are close to values within the full span, but are of the opposite direction. Their values agree very well with those obtained by Žeželj, [2,5], as shown in Tab. 4. Also, values for M_2 moment above “V” columns and within the span are in reasonable agreement, Tab. 4.

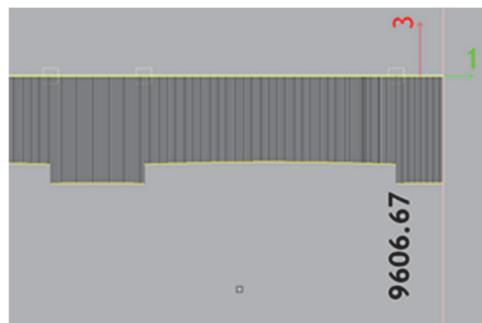
Figure 5: Maximum value of normal force $-N$.

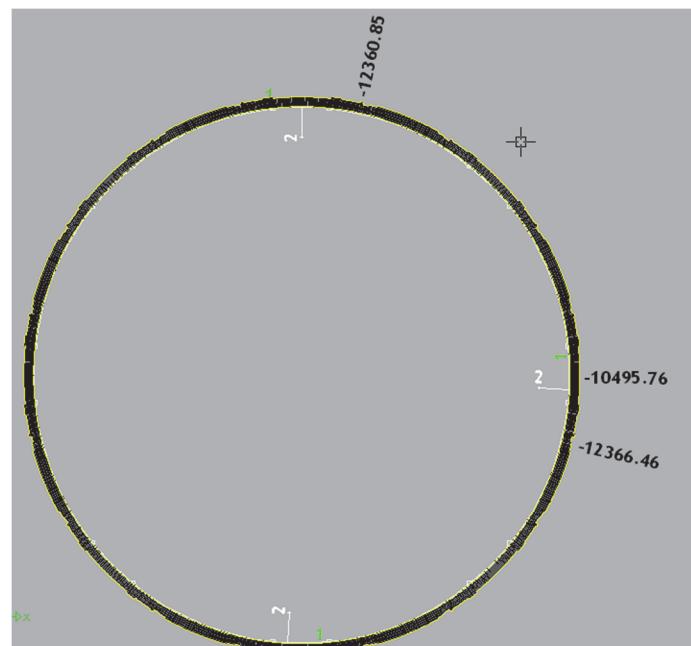
Figure 6: Normal force diagram $-N$.

The pre-stressing force $N = -12366$ kN can be read from the diagram. Due to this force, i.e., after all design force losses have occurred, for all cables except the inclined ones, as well as the dead load of the structure, the roof and snow, the resulting normal force diagram is saw-shaped, which can be clearly seen in the below Fig. 7. Maximum horizontal moment ratio above the columns and in the full span is $M_3 = -5467.56 / 5428.15 = -1.0073$, the difference being only 0.73%.

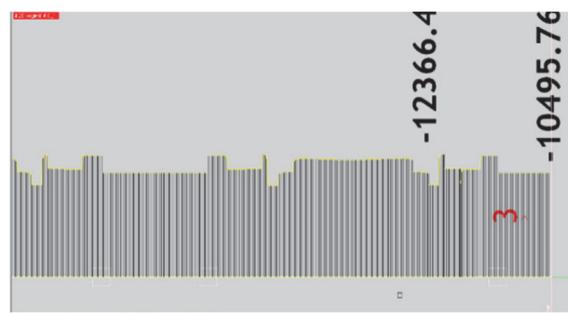
Figure 7: Enlarged portion of normal force diagram: N=-12366.46; -10496; min N=-9221.63kN.

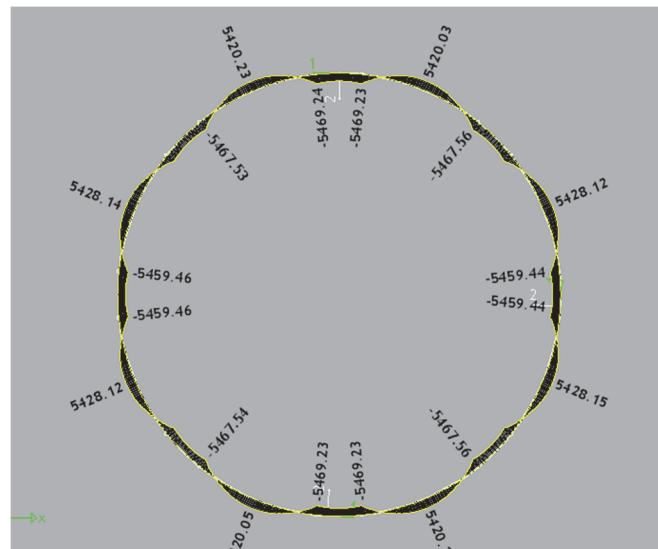
Figure 8: Horizontal plane moment diagram – M3.

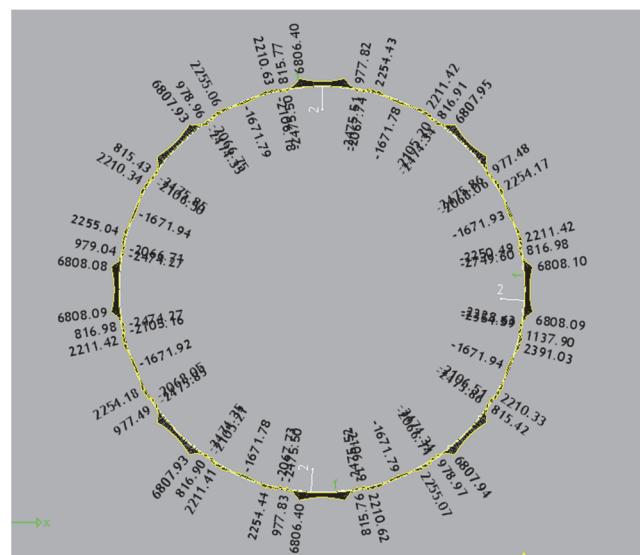
Figure 9: Vertical plane moment diagram: M2=6808.09 kNm; -283.56; 815.76; -2749.60.

Figs. 9-11 show vertical plane moments and their enlarged view in two different ways, respectively. Fig. 12 shows torsion moment diagram and its enlarged view, indicating the highest value in the full span and peaks above the "V" columns, as shown in more detail in Fig. 13. Extreme torsion moments are at approximately 1/5th of the full span, which represents a distance of around 5-5.35 m from the columns. Peaks in torsion diagrams can be seen in the sections above the "V" columns.

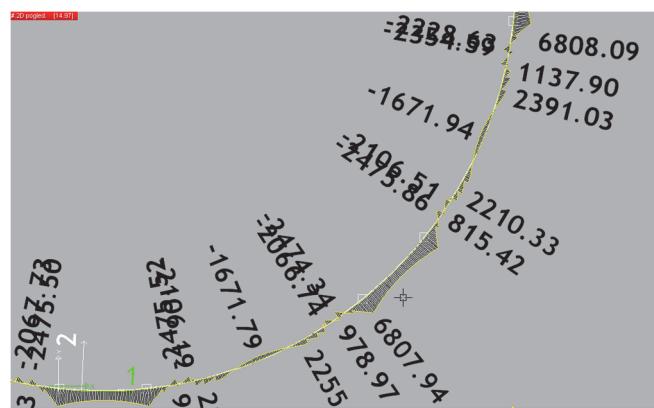
Figure 10: Enlarged portion of the vertical plane moment diagram - M2.

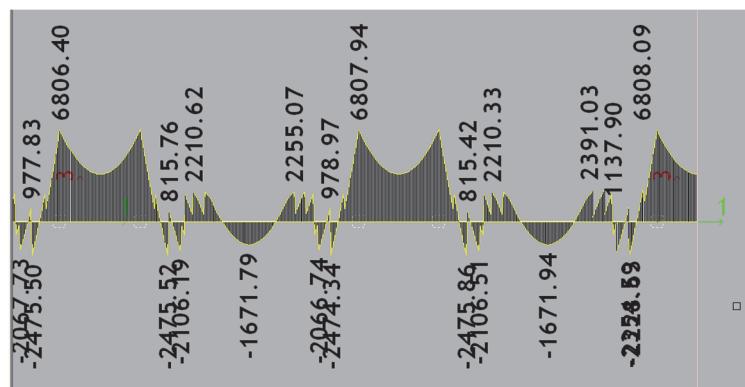
Figure 11: Enlarged portion of the vertical plane moment diagram: M2=6808.09; -2475.52; 815.42; -2106.51; 2210.33; -1671.94kN.

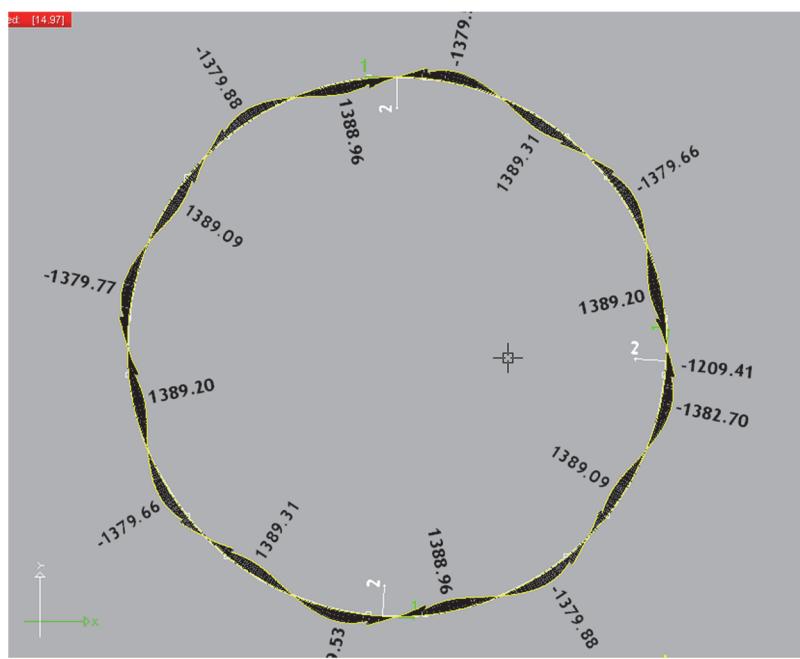
Figure 12: Torsion moment diagram $M_1 = -1389.09 \text{ kNm}$; 1379.88 kNm ; 1209.41 kNm .

For load case 24, compressive force N was caused by permanent pre-stressing forces, i.e., it was determined after all design force losses due to pre-stressing had occurred, for all cables except the inclined ones in the rib of the supporting hoop. In addition, compressive force N was affected by the dead weight of the structure, the roof and snow, which resulted in a saw-shaped diagram, Fig. 7. Maximum M_3 moments were also uniform, like in the previous case, Fig. 8. Contrary to that, resulting M_2 moment in the vertical plane varied considerably, from 6808 to -2750 kNm, Fig. 9. Torsion moment M_1 is also uniform in magnitude, with noticeable difference only above “V” columns, Fig. 12. Anyhow, it does change its direction (sign), Figs. 12-13. The maximum value is at 1/5th of the support hoop full span, Fig. 14.

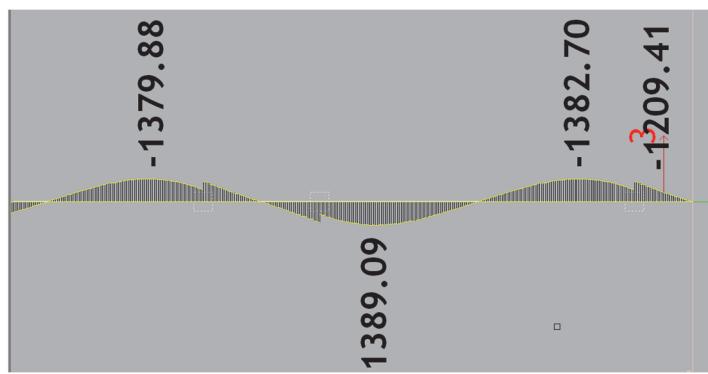
Figure 13: Enlarged portion of the torsion moment diagram - M1.

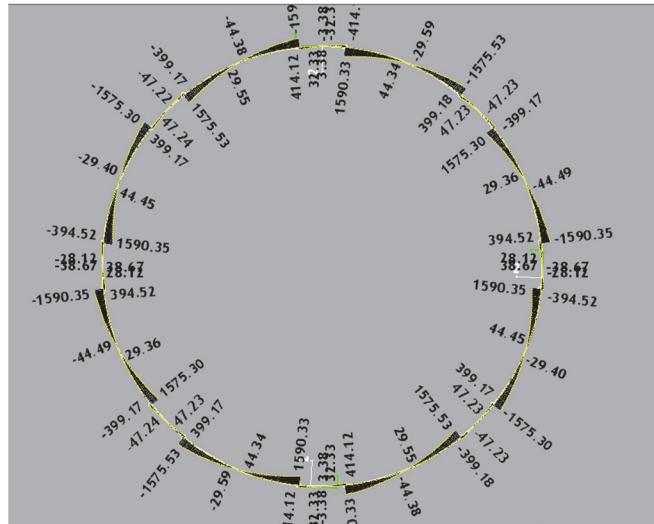
Figure 14: Transversal force diagram in the horizontal plane: $T_2=-394.52$ kN; 1590.35 kN.

Figs. 14 and 15 show transversal force diagram in horizontal and vertical plane, respectively. Fig. 16 shows vertical displacement diagram.

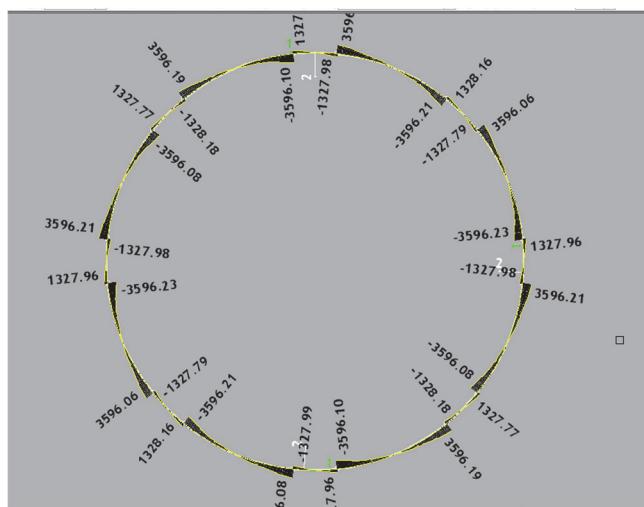
Figure 15: Transversal force diagram in the vertical plane: $T_3=-1327.96$ kN; -3596.21 kN.

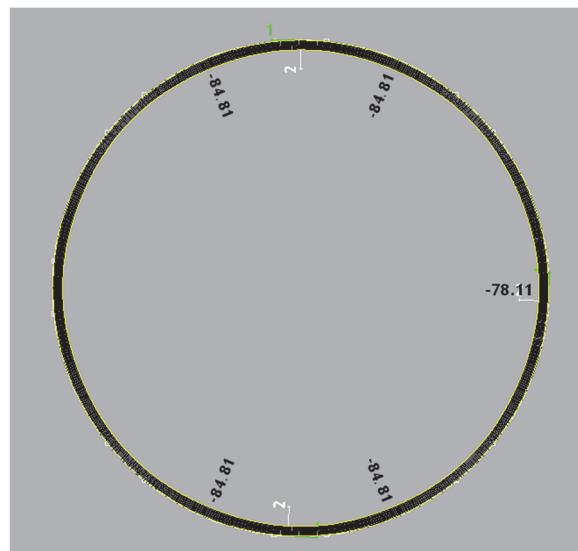
Figure 16: Vertical displacement diagram: $zp=-84$ mm; -78 mm.

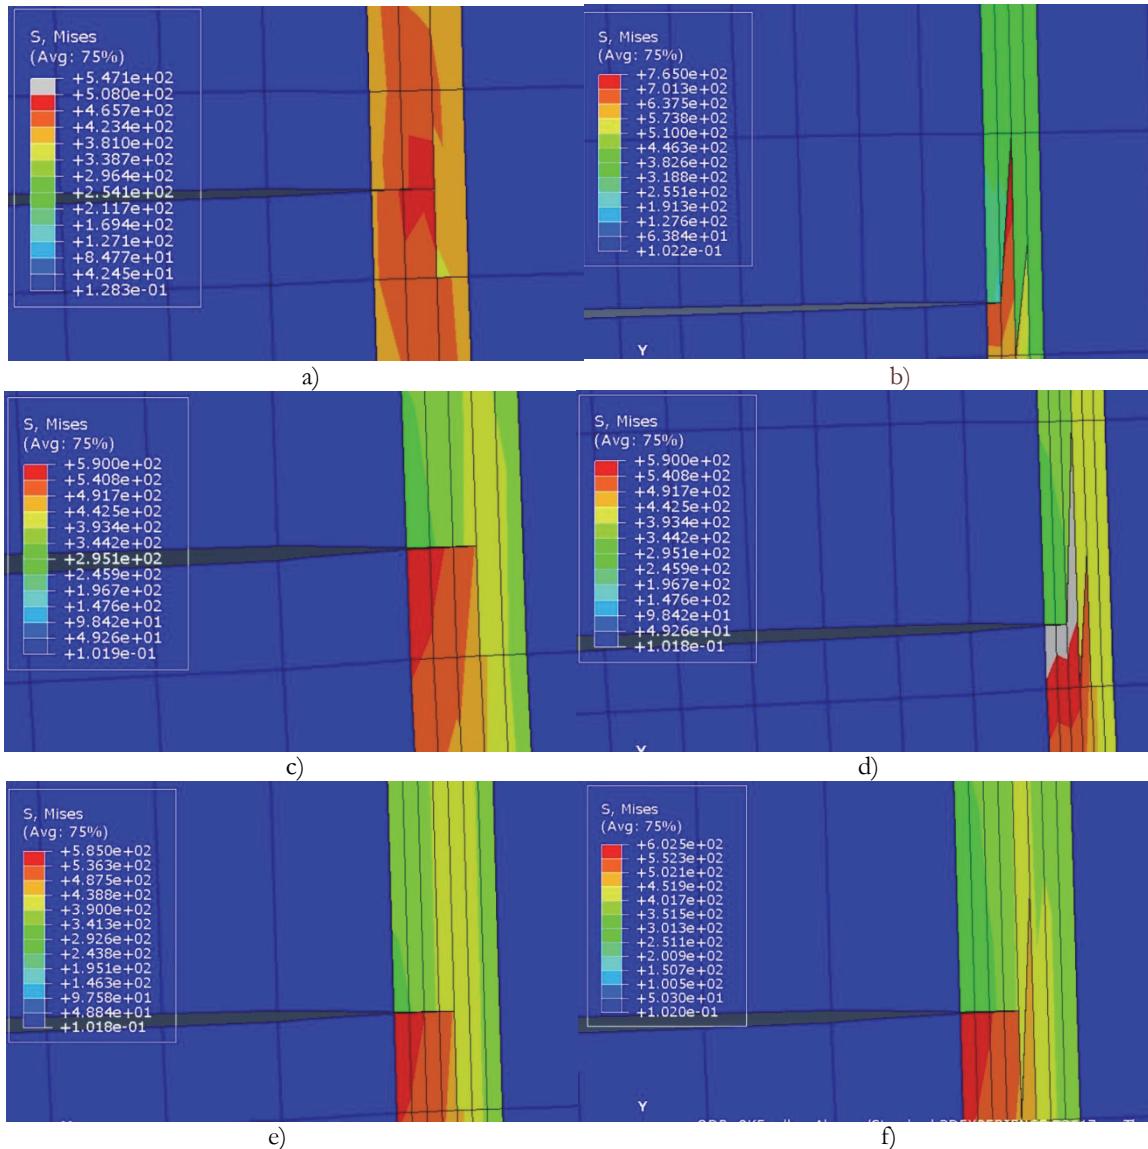
Figure 18: Results of xFEM analysis, distribution of von Mises stress, a) 3 FEs, b) 4 FEs, c) 5 FE, d) 6 FEs, e) 7 FEs, f) 8 Fes.

Following the calculations of forces, moments and support displacements, 2D extended Finite Element Method (XFEM) was used to simulate crack growth in the „V“ column. For this simulation an edge crack of 2.5 mm length in one of the reinforcement bars (5 mm in diameter, made of high-strength steel) was assumed to exist. The main purpose was to determine how the column behaves with a loading defined as a 2 cm displacement of the support due to foundation sinking, corresponding to remote stress of 150 MPa. Foundation sinking was observed in one of the main ring support columns, which was then chosen for this analysis. The support column positions and locations can be seen in Fig. 17. The numerical model with the displacement corresponds to the leftmost column in the figure. The crack was located to pass first through the concrete part, and then through the steel bar. Other details of this analysis can be found in [9], whereas here focus is on von Mises stress distribution, presented in Fig. 18. Steel bar was modelled with different number of elements, from 3 to 8, to minimize the effect of mesh. One can see that the crack reached and entered the steel bar, with maximum stress values around 590 MPa at the crack tip.

As for the crack growth simulation, it can be seen that the total number of finite elements in the steel bar section provided different results in terms of crack behavior, whereas maximum stresses in the vicinity of the crack tip were similar for all cases. In the case where the crack tip was originally at the border between two elements, an unusual zig-zagging crack path was obtained; however, in the case where the crack tip was inside a finite element, the crack would propagate in a straight manner, until it reaches the next FE. Such behavior was never previously encountered by the authors, and further attention should be devoted to this unexpected effect of mesh generation on crack propagation.

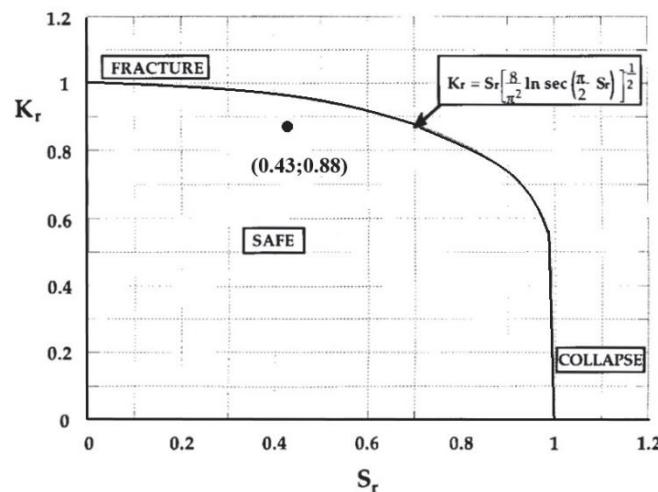
Figure 19: Failure Assessment Diagram with a point (0.43, 0.88).

More sophisticated analysis can be made by using the Failure Assessment Diagram, which takes into account not only linear elastic fracture mechanics parameters, but also a plastic collapse, quantified by the ratio σ_n/σ_c , where σ_n is the net stress and σ_c is the critical stress, as explained and applied in the scope of risk base assessment of structural integrity and life, [30-33]. In the scope of a conservative approach, applied here the net stress is taken as equal to the maximum value at the crack tip (590 MPa). If the critical stress is taken as the half-way between YS and TS, (1375 MPa for YS=1250 MPa and TS=1500 MPa), X coordinate is $590/1375=0.43$. The Y coordinate is already defined by the ratio $K_I/K_{Ic}=0.88$, so the point in FAD is just below the limit curve, Fig. 19.
