Damage evolution in freeze cast metal/ceramic composites exhibiting lamellar microstructures

ABSTRACT. The damage evolution in a single domain aluminium/alumina freeze-cast composite has been examined using 3D X-ray computed tomography (CT). A single domain was extracted and loaded incrementally at an orientation of 45° to the lamellae, with the damage being assessed after each of eight compressive loading steps. Prior to loading, significant damage was observed at the metal-ceramic interface – this is thought to have formed during machining and can be ascribed to weak interfacial bonding associated with the Cu coating applied to the ceramic preform prior to metal infiltration. Further interfacial damage was seen to initiate after loading to 170MPa and to develop with each subsequent load step. Damage was also observed in the ceramic lamellae, with a series of parallel cracks forming across the alumina, perpendicular to the domain orientation. These sets of parallel, intra-lamellae cracks were closely spaced, but initiated independently, with coalescence only occurring at higher loads. Both the interfacial and intra-lamellae cracking initiated after loading to 170MPa, with the int

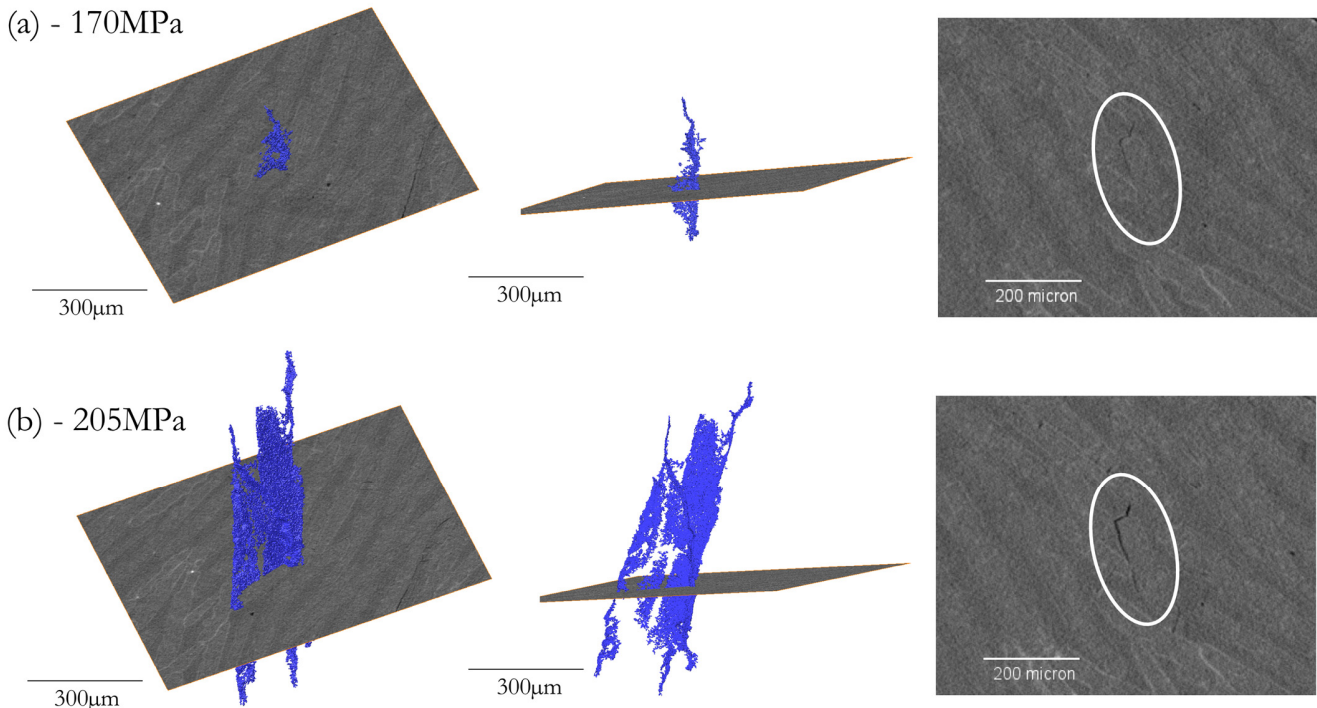
Figure 6: 2D/3D representation of the extent and development of a crack at the metal-ceramic interface after loading to (a) 170MPa and (b) 205MPa. The tracked damage corresponds to the feature circled in white in Fig. 4.

Increasing the load to 205MPa caused the tracked interfacial feature to increase in size to approximately $600\ \mu\text{m} \times 300\ \mu\text{m}$. The damage is wrapped around and growing along the interface of a truncated ceramic lamella. It is clear at this point, and after the subsequent load increments, that the size of the tracked and segmented interfacial crack is larger than that suggested on the corresponding 2D virtual slice; this phenomenon can be seen in Fig. 6b.

anisotropic at this stage, with crack growth preferentially occurring perpendicular to the orientation of the images shown in Fig. 4 (in accordance with the orientation shown in Fig. 6).
