# The influence of technological defects on the mechanical behavior of CFRP during buckling under compression based on DIC data and acoustic emission

S.V. Slovikov, D.S. Lobanov, E.A. Chebotareva, V.A. Melnikova  
*Center of Experimental Mechanics, Perm National Research Polytechnic University, Russia*  
sslovikov@ya.ru, <https://orcid.org/0000-0003-3884-3882>  
cem.lobanov@gmail.com <https://orcid.org/0000-0003-1948-436X>  
cem.chebotareva@mail.ru <https://orcid.org/0000-0002-6374-6964>  
V.A.Melnikova@pstu.ru <https://orcid.org/0000-0002-5163-2054>

The aim of the study was to evaluate the impact of internal technological defects on the mechanical performance of CFRP under buckling conditions during compression tests, utilizing data gathered from an acoustic emission signal recording system and digital image correlation.

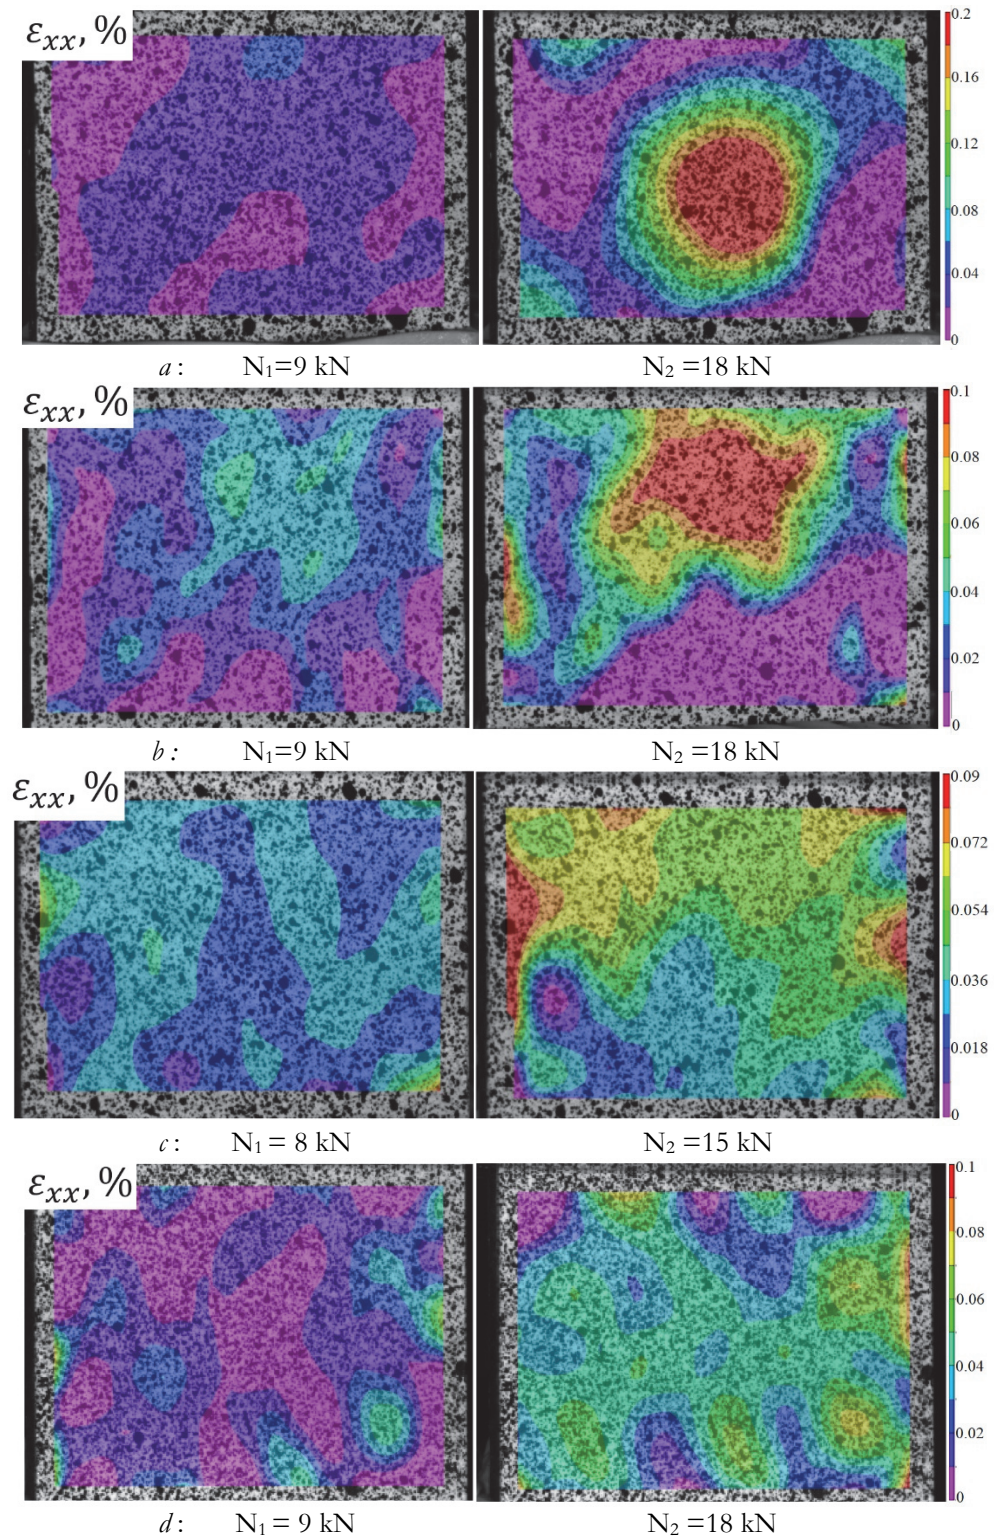
In Fig. 12, the evolution of strain fields along the  $\epsilon_{xx}$  component on the surface of the samples is depicted, from the moment when the load value ( $N_1$ ) was 50% lower than the load value corresponding to the onset of fiber fracture ( $N_2$ ), up to the moment of failure.

Zones with increasing deformation values under loads preceding failure can be observed by analyzing the evolution of deformation fields in the defect area. Notably, these zones are absent in samples without defects. This observation indicates the influence of the studied defect sizes on the mechanical behavior of the material under compressive load.

Figure 12: Evolution of deformation fields by component  $\epsilon_{xx}$  during delamination processes(  $N_1, N_2$  - levels of compressive load): *a* - dry-spot a circle, *b* - dry-spot a square, *c* - without a defect, *d* - wrinkles.
